## INSPECTION OF DAM AND RESERVOIR IN CERTIFIED STATUS

Name of Dam Rattlesnake Canyon Dam No. 1029-3 County Los Angeles  
 Type of Dam Earth Type of Spillway Concrete weir and side channel  
 Water is ~25 feet below spillway crest and ~31 feet below dam crest.  
 Weather Conditions Sunny  
 Contacts Made Willie James with IRWD  
 Reason for Inspection Maintenance Inspection

Photos taken? Yes  No  *CML* 8/10/2022 Inspected by C. M. Lancaster  
 cc for Owner/Book Date of Inspection 5/11/2022  
 Date of Report 8/5/2022 *RD* 8/10/2022

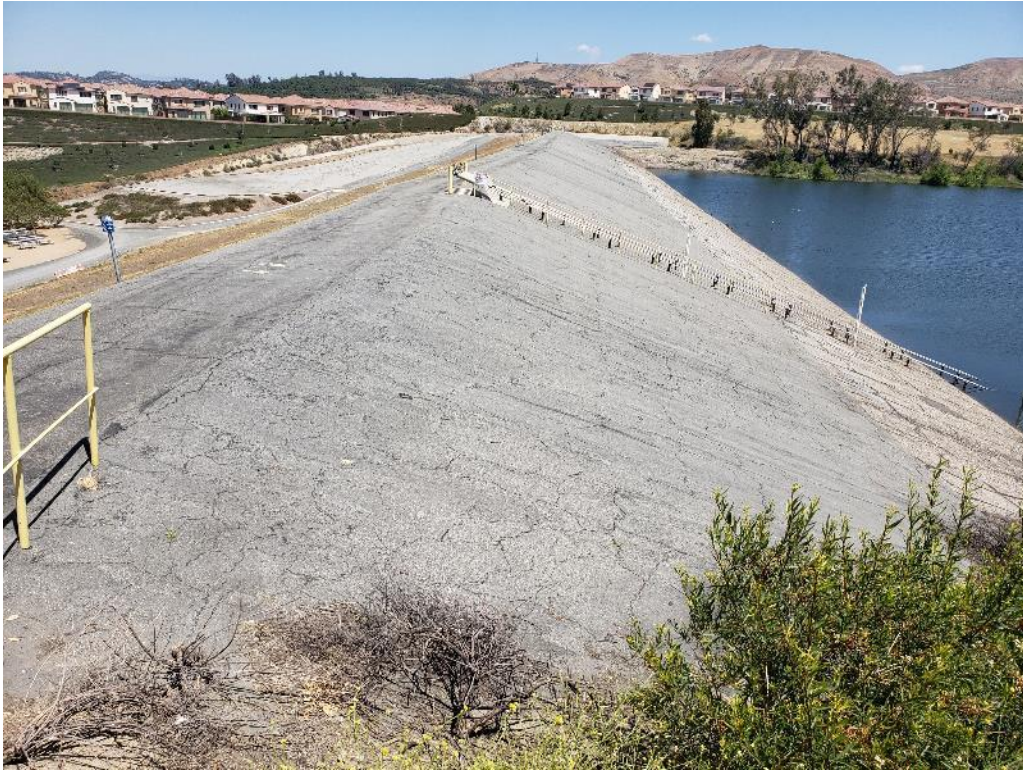
1. Upstream face of the dam observed from the left abutment.

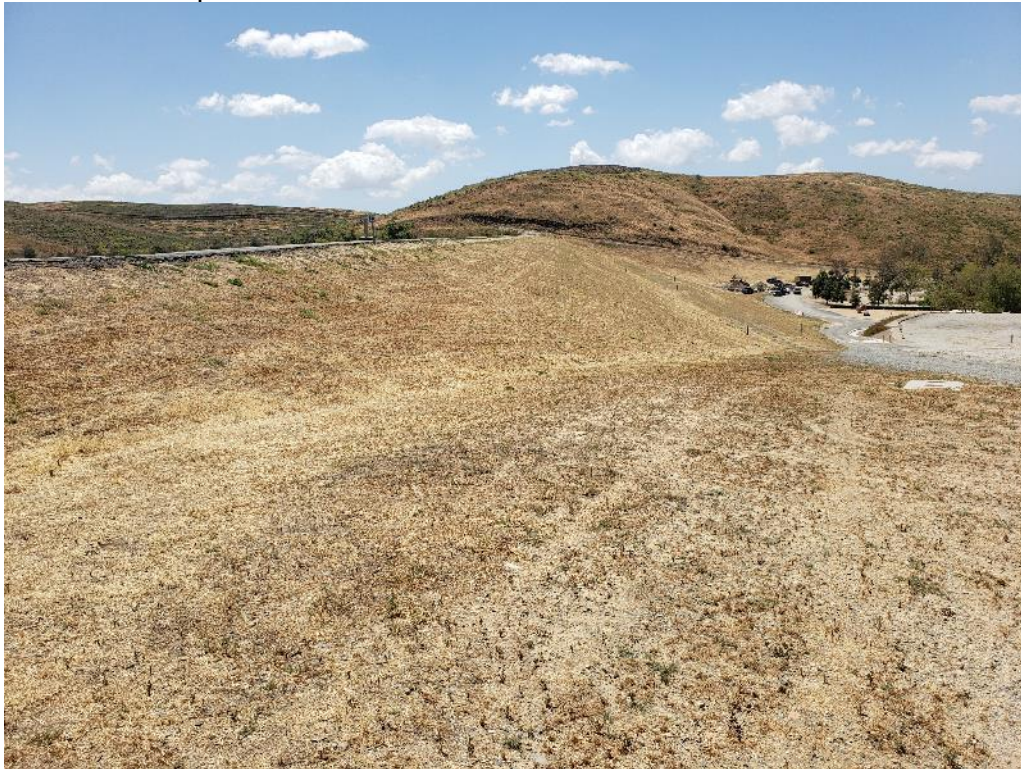
2. Downstream face of the dam observed from the right abutment.

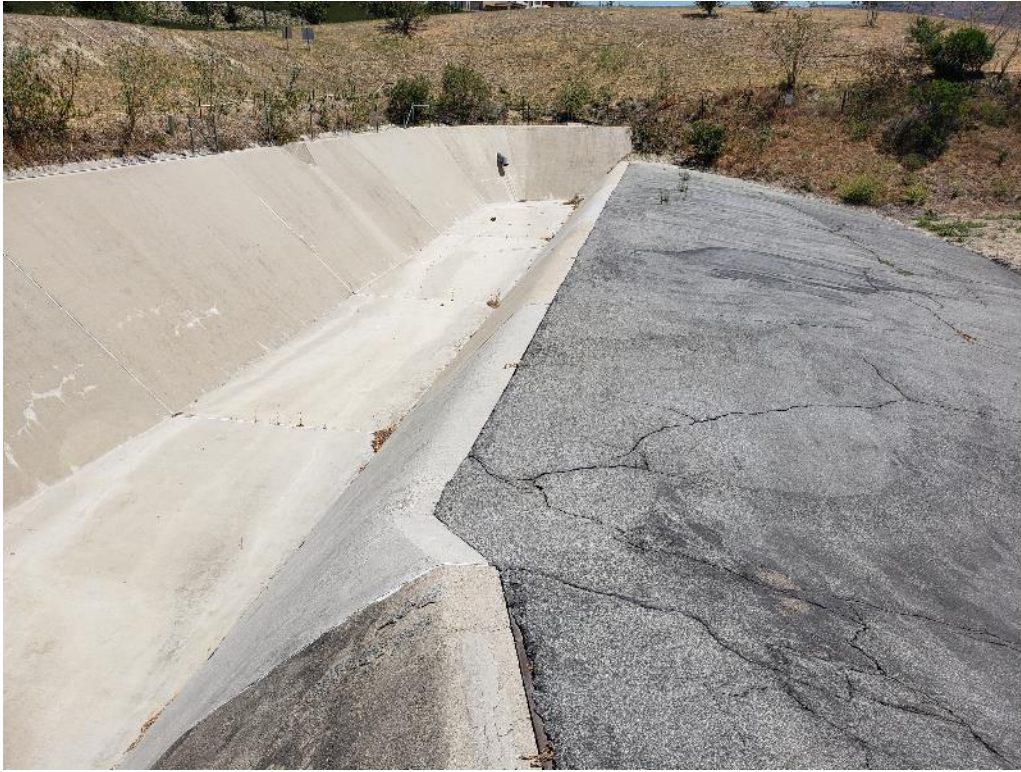
3. Spillway approach, weir, and side channel.

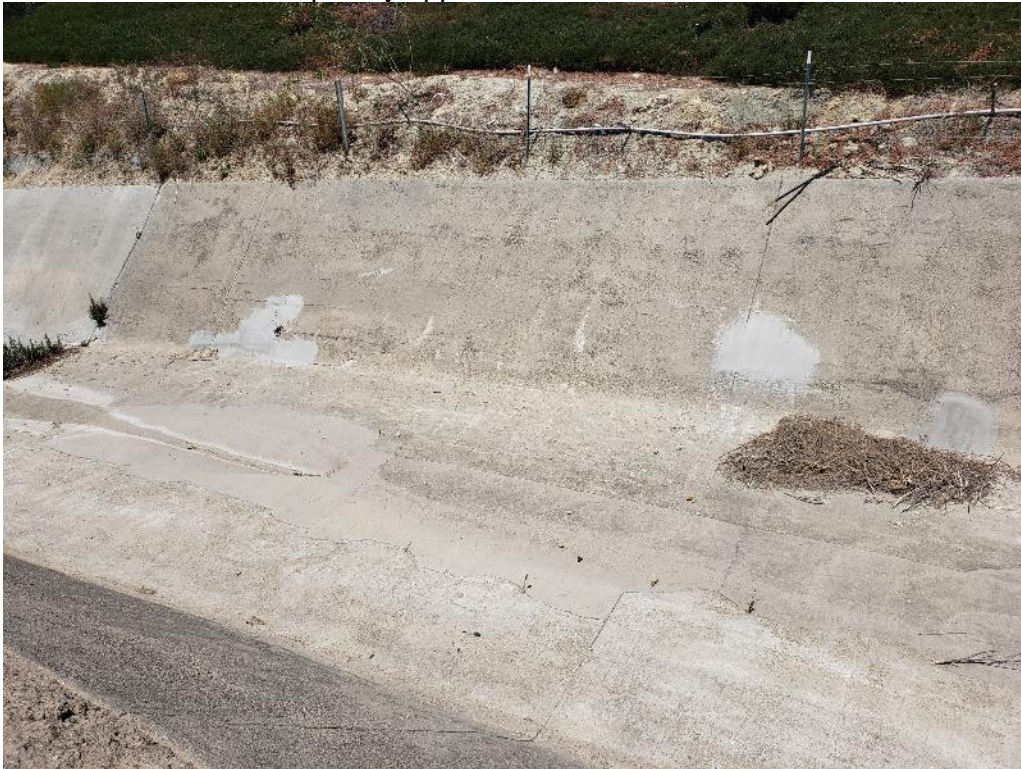
4. Repairs to the spalls with exposed wire mesh reinforcement.

As requested, the spalls with exposed wire mesh reinforcement have been satisfactorily repaired since the last inspection (Photo 4).

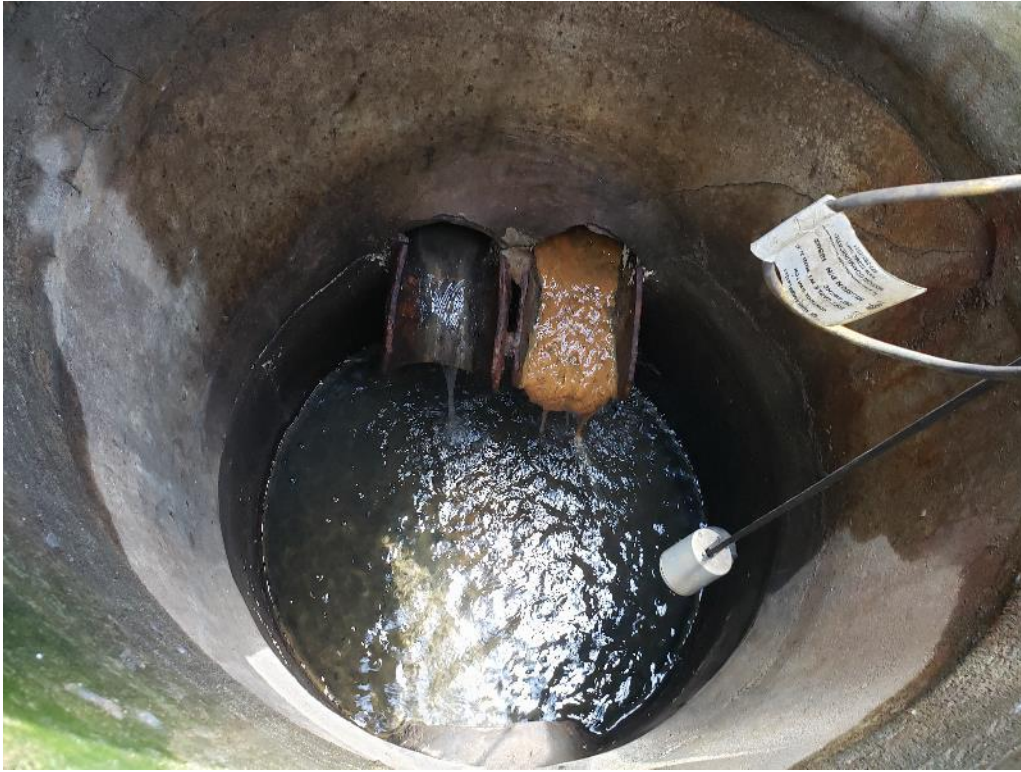
No signs of seepage were observed on the downstream face, groins, or toe of the dam. There are 6 subdrain pipes (Drains 2-5, 8, and 11) that outfall into a seepage vault downstream of the dam toe, and 2 drains (Flow Point North and Flow Point South) that outfall into a seepage vault in the downstream spillway channel. The following flow rates were estimated during the inspection:

Drain 2:	Dry	Drain 5:	Dry	FP North:	~1-2 gpm
Drain 3:	~0.5 gpm	Drain 8:	Dry	FP South:	~1 gpm
Drain 4:	~0.25 gpm	Drain 11:	Dry

5. Flow Points North and South.

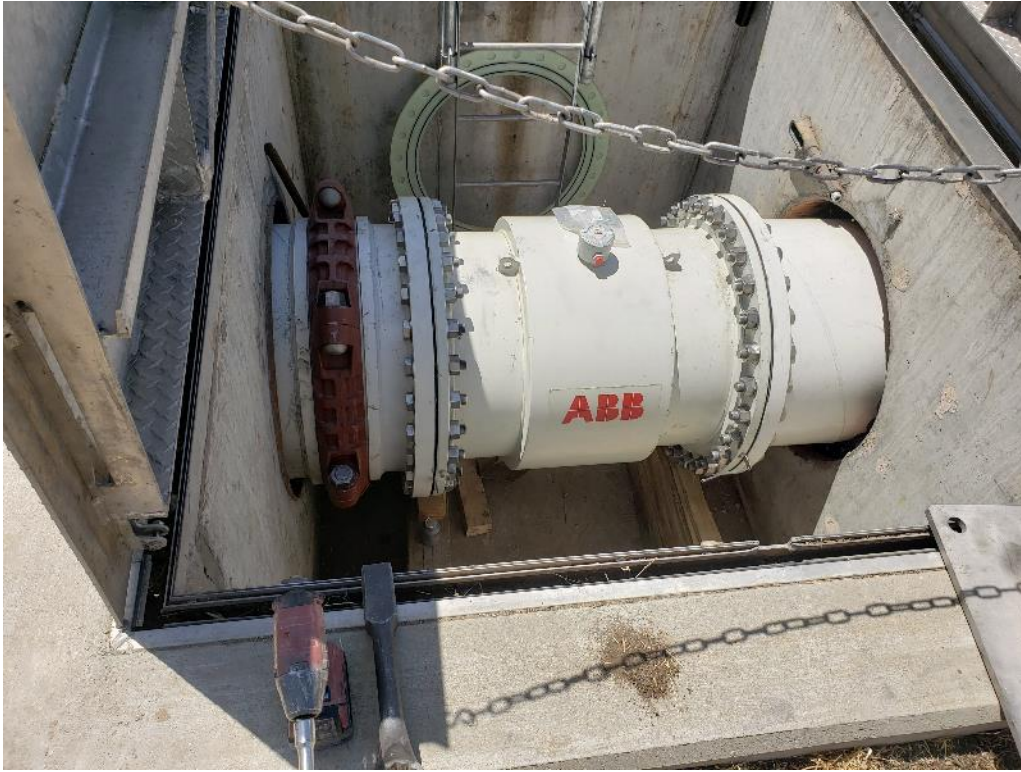
<u>Dam</u>	The asphalt-lined crest was level and well-aligned with some minor cracking. The upstream asphalt-lined face was uniform with some minor cracking. Minor cracks in the asphalt lining are long standing and do not pose a dam safety concern at this time. The visible portions of the faces, groins, and downstream toe appeared to be in satisfactory condition with no signs of instability or distress. Vegetation control was satisfactory. No significant rodent activity was observed.
<u>Spillway</u>	The approach, weir, side channel and downstream chute were clear and unobstructed. The concrete surfaces show some signs of aging but appeared to be in satisfactory condition with no significant cracks or spalls.  As requested, the spalls with exposed wire mesh reinforcement have been satisfactorily repaired since the last inspection.
<u>Outlet</u>	The low-level outlet is controlled by four upstream gate valves (top, middle, bottom, and main) and two downstream valves. As requested, the broken stems for the top and middle valves were repaired and the actuators were replaced. Reportedly, the valves were then cycled following the repair work. The downstream valve at the downstream toe was relocated a few feet downstream in May 2022 as part of the low-level outlet flowmeter project, and the valve was subsequently cycled. All outlet controls were last fully cycled in our presence on March 28, 2019. Arrangements will need to be made to fully cycle all outlet controls during the next inspection.  The flowmeter project was nearing completion during this inspection. The valve, manway, and flowmeter appeared to be installed satisfactorily and there were no dam safety concerns observed (Photos 6 and 7).

7. New flowmeter.
