STATE OF CALIFORNIA
 CALIFORNIA NATURAL RESOURCES AGENCY
 DEPARTMENT OF WATER RESOURCES
 DIVISION OF SAFETY OF DAMS

INSPECTION OF DAM AND RESERVOIR IN CERTIFIED STATUS

Name of Dam Sand Canyon Dam No. 1029-2 County Orange
 Type of Dam Earth Type of Spillway Concrete weir and channel
 Water is 11.5 feet below spillway crest and 20 feet below dam crest.

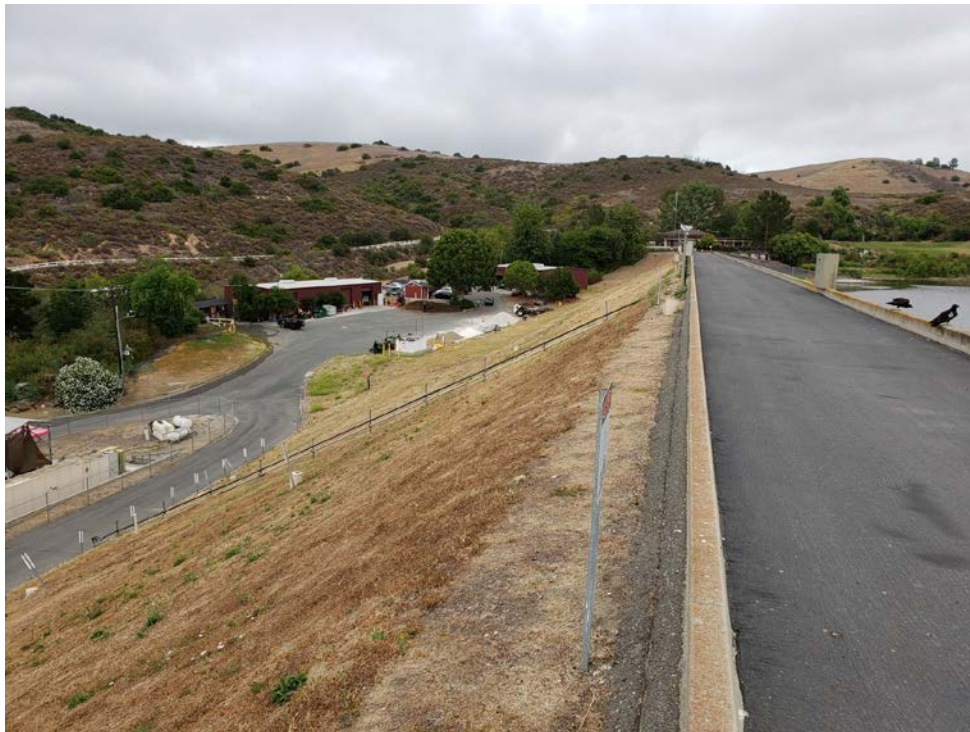
View of the crest and downstream slope.

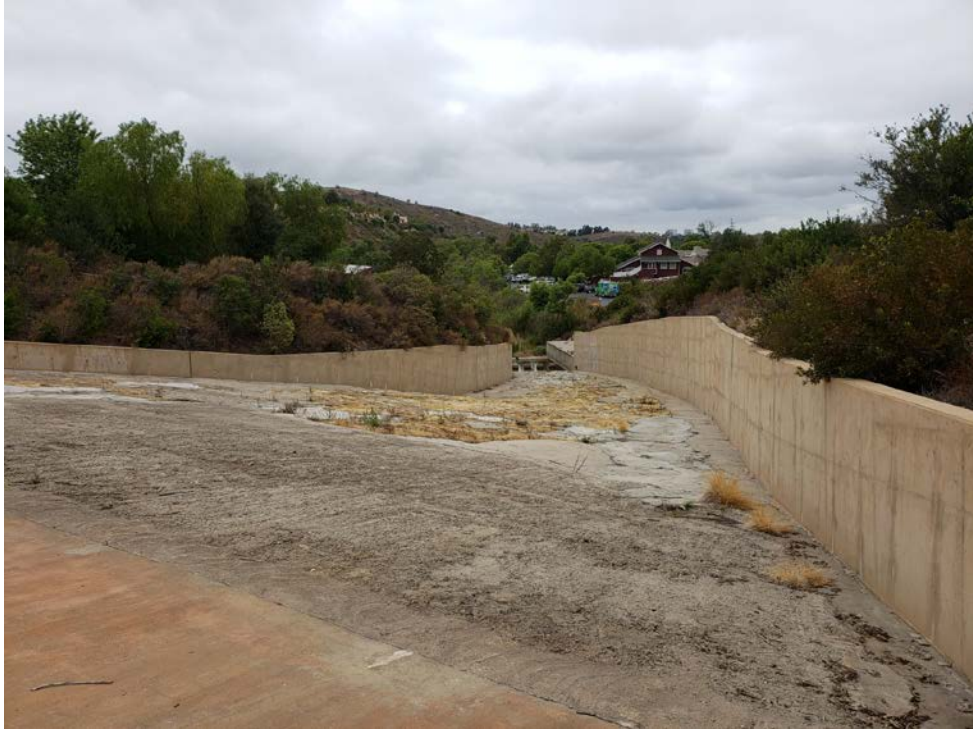
Looking downstream the spillway channel.

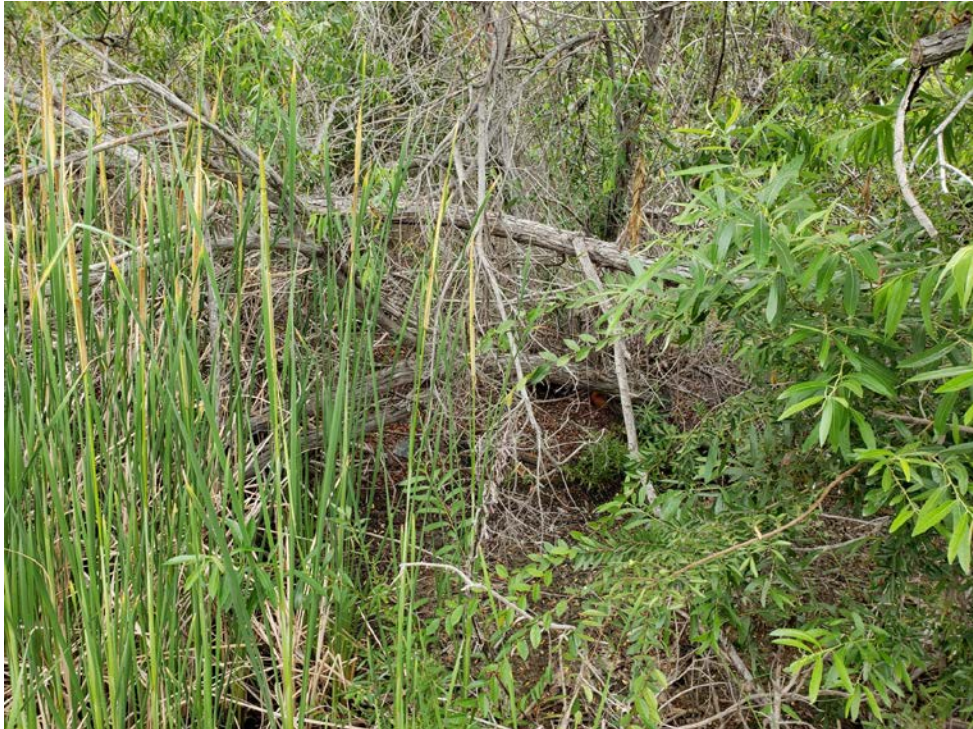
- As repeatedly requested in our past inspection reports since 2016, the exit to the outlet is obstructed and choked with vegetation. The outlet is an integral component to dam safety and must be maintained clear. The outlet exit portal needs to be uncovered and the surrounding exit area needs to be cleared by November 1, 2022.
- All the outlet valves need to be operated during our next inspection.
- Updated instrumentation data was submitted and reviewed.

<u>Dam</u>	The asphalt road, curb, and parapet wall on the crest of the dam appeared to be well-aligned, level, and in satisfactory condition. The visible portion of the upstream asphalt-lined slope appeared stable and in satisfactory condition. The downstream slope appeared to be uniform, stable, and in satisfactory condition. Vegetation and rodent control appeared satisfactory with bait traps strategically placed on the embankment. The downstream toe area was dry and appeared normal.
<u>Spillway</u>	The approach, weir, downstream channel, and tailworks of the spillway were open and clear. The concrete weir and walls appeared to remain in satisfactory condition. The unlined rock channel with filled in areas of dental concrete appeared to be in satisfactory condition.
<u>Outlet</u>	The outlet consists of four upstream gates and three downstream valves. According to the logs, all the valves were last operated on April 14, 2022. We last witnessed the operation of all the outlet valves during the January 14, 2020, inspection with no difficulties encountered. All the outlet valves are due to be operated during our next inspection. The downstream outlet exit portal could not be detected and is choked with vegetation. The outlet is an integral component for dam safety and must be maintained clear. DSOD has repeatedly requested the exit to the outlet be cleared in our inspection reports since 2016.

The outlet exit portal is obstructed and the surrounding area needs to be cleared.
