STATE OF CALIFORNIA  
CALIFORNIA NATURAL RESOURCES AGENCY  
DEPARTMENT OF WATER RESOURCES  
DIVISION OF SAFETY OF DAMS

## INSPECTION OF DAM AND RESERVOIR IN CERTIFIED STATUS

Name of Dam Syphon Canyon Dam No. 1029-4 County Orange  
Type of Dam Earth Type of Spillway Concrete weir and open channel  
Water is 25.7 feet below spillway crest and 32.7 feet below dam crest.

Reason for Inspection Periodic Maintenance Inspection

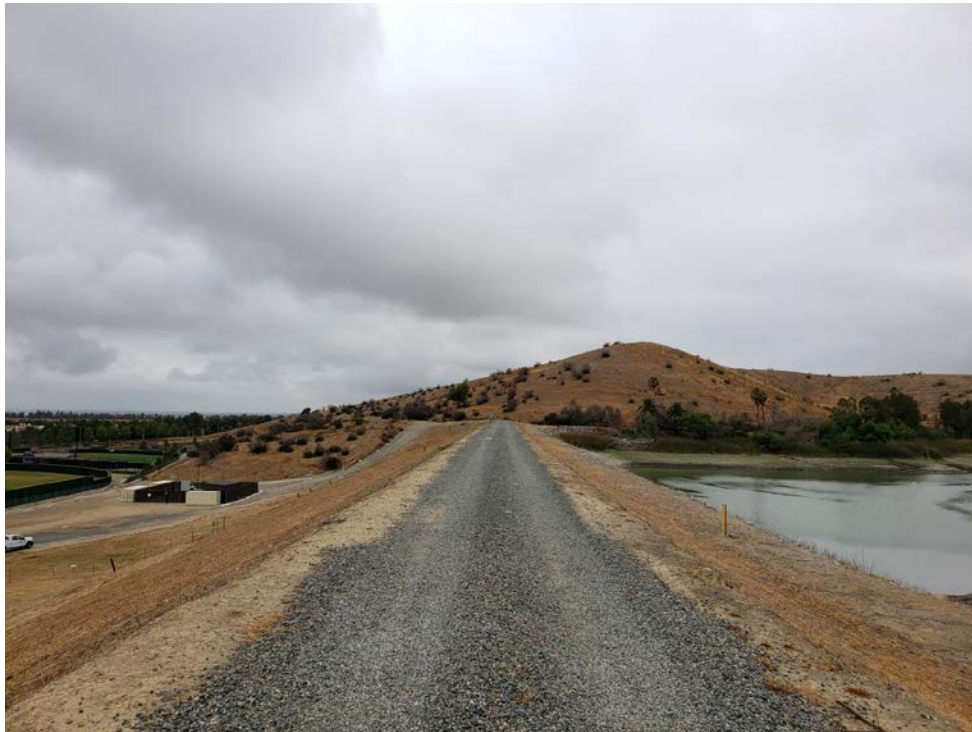
<u>Dam</u>	The gravel covered crest appeared to be well-aligned, level, and in satisfactory condition. The visible portion of the upstream slope and downstream slope appeared to be stable, uniform, and in satisfactory condition. Vegetation and rodent control were adequate. The objectionable vegetation requested to be removed during the last inspection was satisfactorily completed. The groins and downstream toe of the dam were dry and appeared normal.
<u>Spillway</u>	The approach, channel, and downstream exit of the spillway were open and clear. The concrete control section and gunite lined channel remains serviceable and in satisfactory condition.
<u>Outlet</u>	The outlet consists of an upstream 12-inch butterfly valve and two downstream 16-inch butterfly valves. According to the logs, all the valves were last operated on April 14, 2022. All the valves were fully cycled in our presence during the January 14, 2020, inspection. The outlet valves will need to be fully cycled during our next inspection. The exit portal that enters the underground storm drain was unobstructed.

Looking across the crest of the dam.

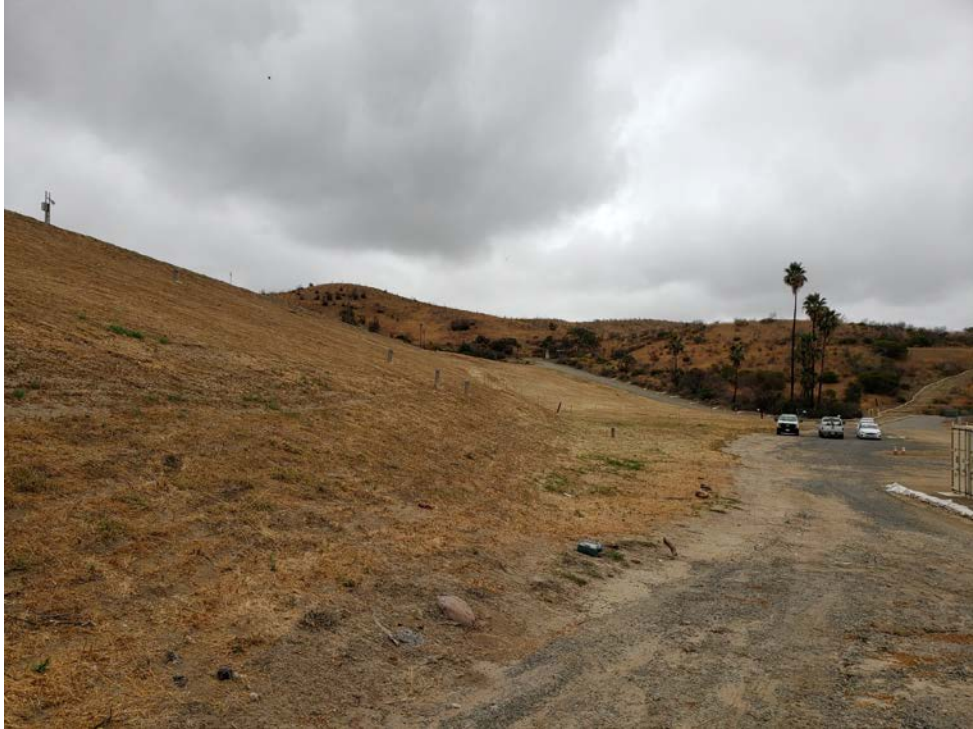
<u>Seepage</u>	There were no signs of seepage detected on the downstream slope, groins, or toe of the dam. The seepage from the toe drain was dripping. The seepage was normal for the low reservoir level.
<u>Instr.</u>	Instrumentation for this dam consists of 12 piezometers and 1 seepage point. The piezometers and toe drain are measured on a monthly basis. The latest instrumentation report was submitted on April 24, 2021, and includes data through December 2020.  Piezometers P2A, P2B, P4, P5, P6, P7, P8, and P9 were converted to vibrating wire piezometers in 2015. Piezometers P2B and P4 have shown the most erroneous data. The instrumentation report notes that the owner is having problems with the data logger, and the data logger was in the process of being fixed including a re-calibration. The open well piezometers continue to show predictable trends and respond normally to reservoir levels.

View of the downstream slope and toe area.

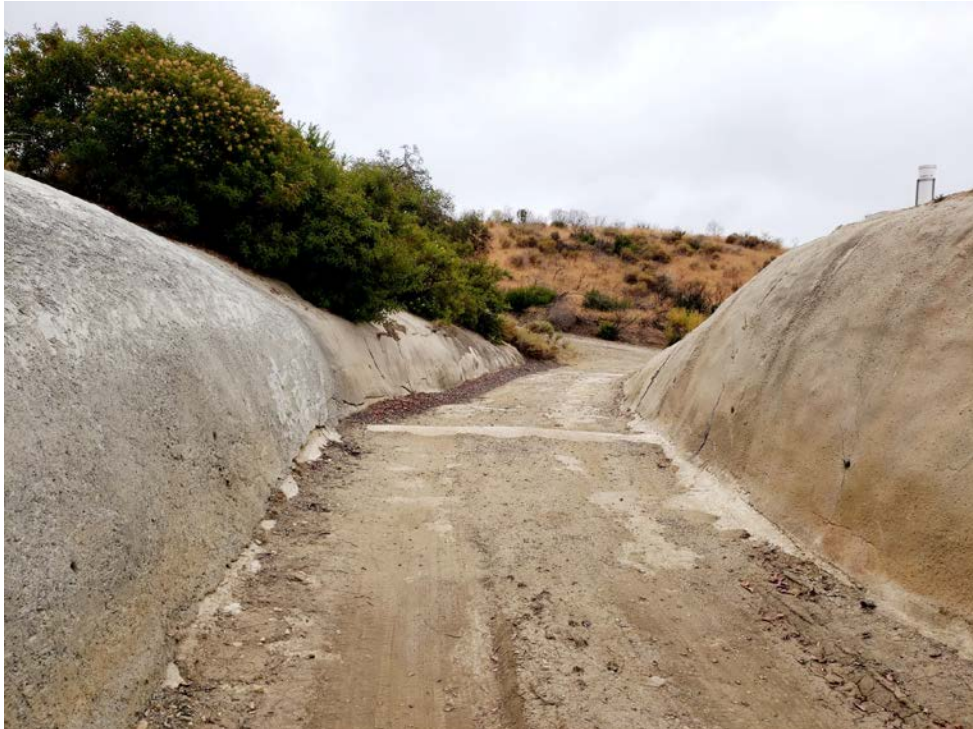
The spillway was open and clear.

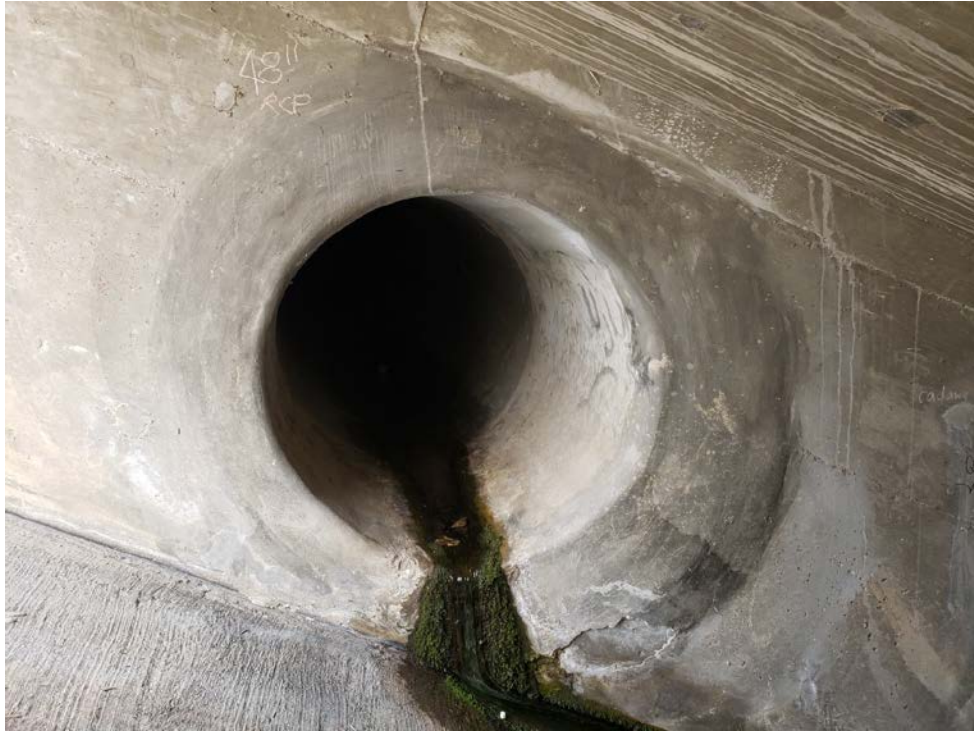
The exit to the outlet portal was unobstructed.

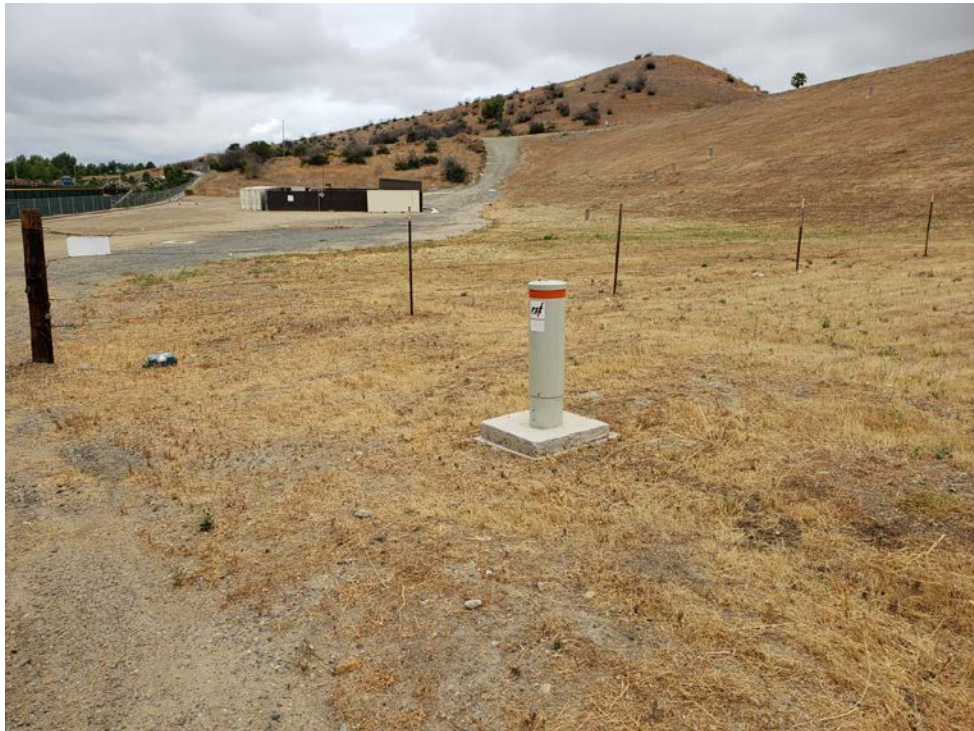
New piezometer installed during the exploration work.
