Annual Surveillance Report January 2021 to December 2021 for Sand Canyon Dam DSOD Dam No. 1029-002

Irvine, California

September 29, 2022
GEI Project No. 1901888

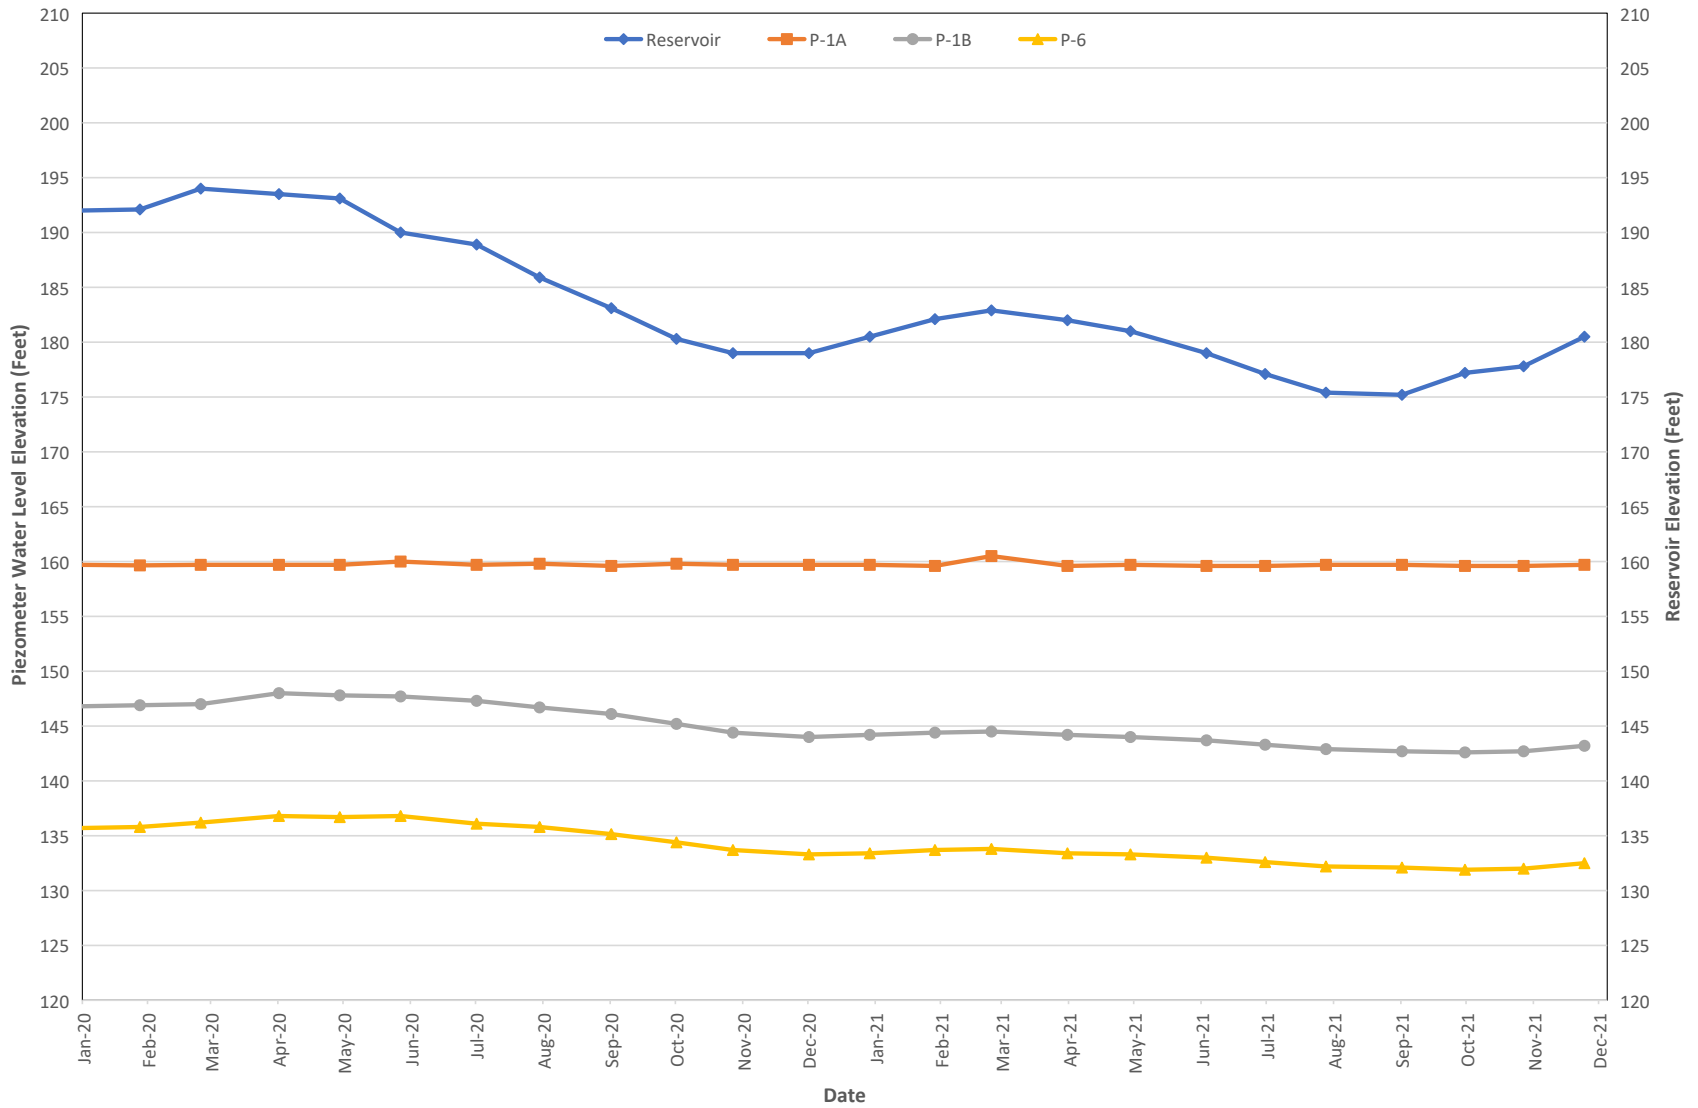
Figure 4
SAND CANYON DAM
2-YR OPEN WELL PIEZOMETER AND RESERVOIR WATER SURFACE ELEVATIONS
OPEN WELL PIEZOMETERS P-1A, P-1B, AND P-6
JANUARY 2020 THROUGH DECEMBER 2021

Piezometers P-1A, P-1B, and P-6 are located near the right end of the dam along a similar cross section of the dam. Piezometers P-1A and P-1B are located on the crest of the dam, while Piezometer P-6 is near its toe. The tip of Piezometer P-1A (Elevation 159.3 ft) is located within the embankment, while Piezometers P-1B and P-6 have tips within the foundation alluvium (Elevations 132.9 ft and 127.7 ft, respectively). Piezometer P-1A remained fairly consistent during 2021 (Figure 4) and has historically shown slight to no response to the reservoir water level changes (Figure 9). Piezometers P-1B and P-6 tracked the reservoir level indicating groundwater levels within the alluvium foundation are responsive to reservoir water levels changes. These piezometers remained within historical limits (Figures 4 and 9).

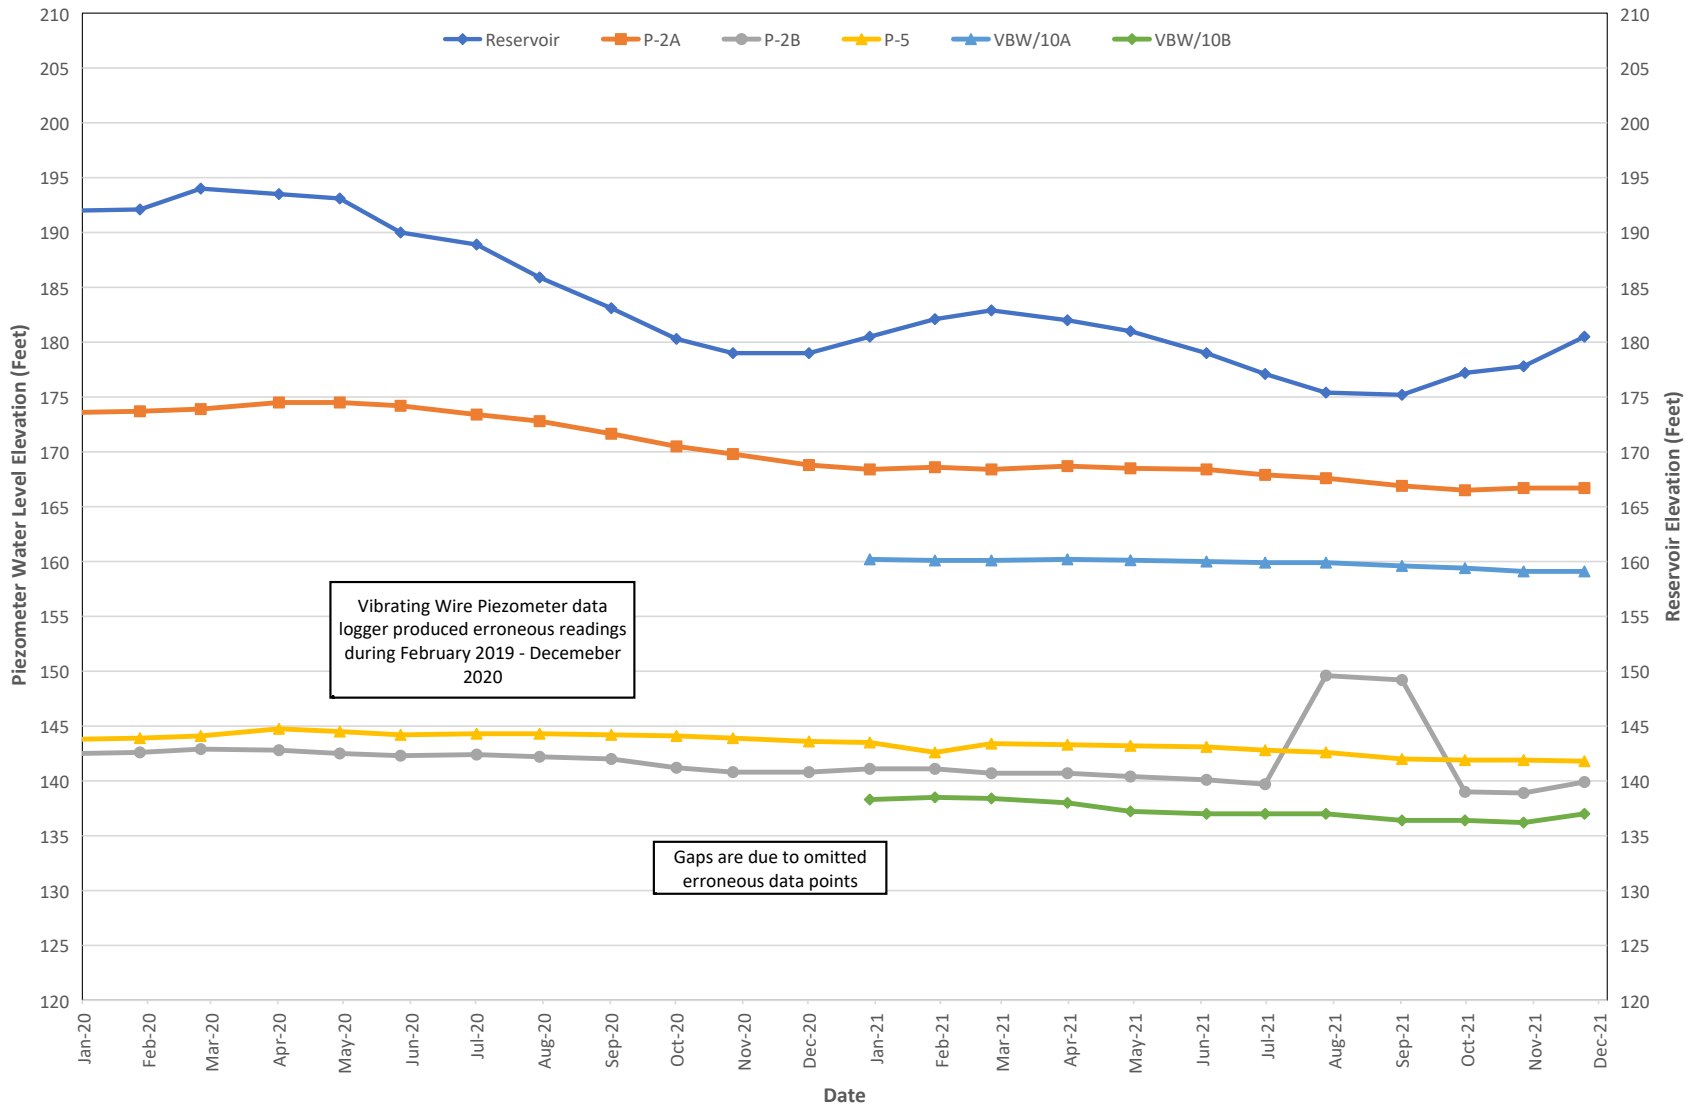
Figure 5
SAND CANYON DAM
2-YR PIEZOMETER AND RESERVOIR WATER SURFACE ELEVATIONS
PIEZOMETERS P-2A, P-2B, P-5, VBW/10A, AND VBW/10B
JANUARY 2020 THROUGH DECEMBER 2021

downstream face of the dam. All five piezometers are near the maximum section of the dam. The tips of Piezometer P-2A, P-2B, P-5, VBW/10A, and VBW/10B are at Elevations 153.9 ft, 123.8 ft, 129.6 ft, 148 ft, and 136.1 ft, respectively. Piezometers P-2A installed within the dam embankment, generally tracked the reservoir levels during 2021 (Figure 5). As stated above, Vibrating Wire Piezometers VBW/10A and 10B were producing erroneous digital readings from February 2019 to December 2020. The water level observed in VBW/10A appears to follow the historical trend before the erroneous readings. The water levels observed in piezometers P-2A and VBW/10A remained within historical levels (Figures 5 and 10).

Piezometers P-2B, P-5, and VBW/10B are installed within the foundation alluvium. Piezometer P-2B tracked the reservoir levels slightly during the 2021 review period, see Figure 5. The exceptions were on August 24, 2021, and September 28, 2021, where the readings in P-2B rose approximately 10 ft beyond its normal range but returned to normal levels after September. GEI believes the unusual rise in readings were due to reading errors. Piezometer VBW/10B had slight fluctuations with a maximum change of 2.3 ft during the review period. P-5 in 2021 had slight fluctuations with a maximum change of 1.6 ft during the review period. The water levels observed in VBW/10B, P-2B, and P-5 piezometers remained within historical levels (Figure 10) during the 2021 review period.

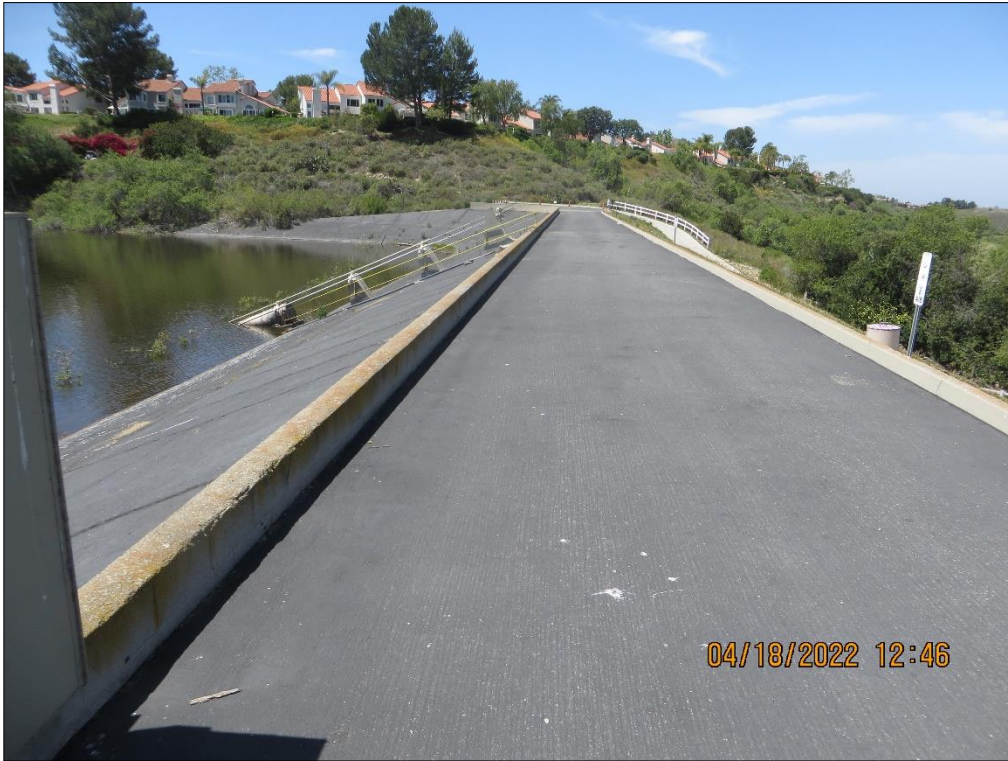
The crest of dam was walked, and the asphalt concrete surface was observed to be in good condition with no signs of movement and significant cracking, see Photos 1 through 3. Minor temperature related AC cracking was observed near the left abutment, see Photos 2 and 3. The exposed upstream AC-lined slope face above the reservoir water level had some long-standing transverse and longitudinal shrinkage-expansion cracking with vegetation growing within the cracks, see Photo 4. GEI also observed brush growing on the upstream slope within the reservoir near the water line, see Photo 4. The downstream toe area, downstream embankment slope, and both groin areas were inspected. No signs of surficial movement, instability, or wet spots were seen.

Photo 1) AC paved crest and upstream face looking towards the left abutment, including 1 foot-high curb wall.

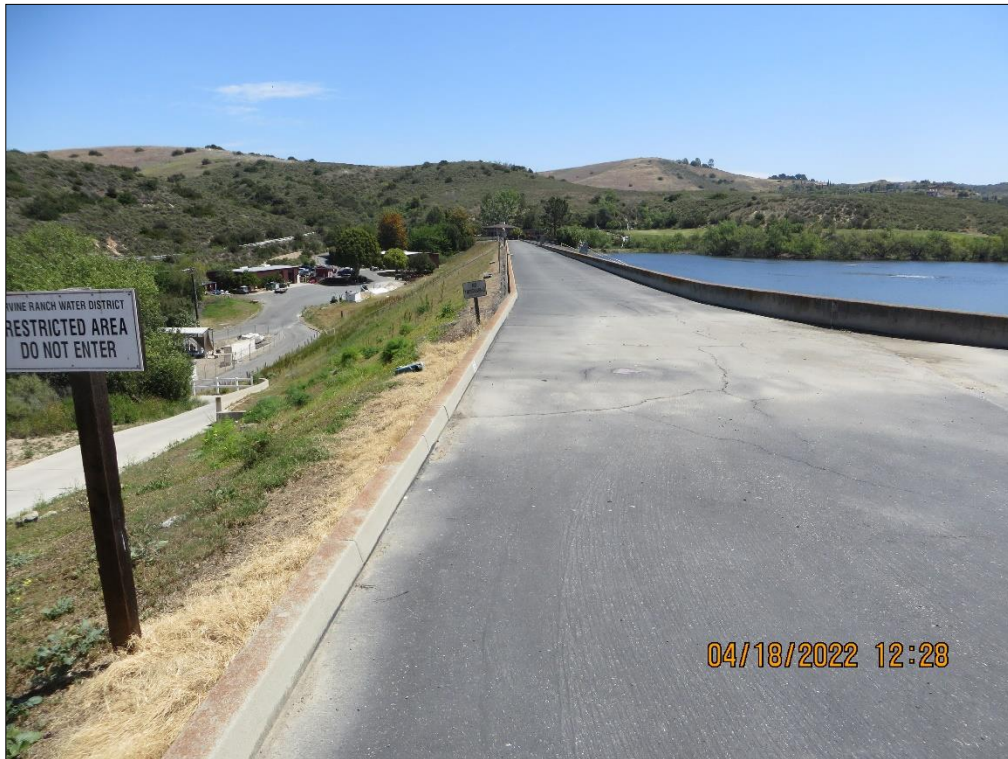
- 11) The AC pavement on the dam crest has minor temperature expansion cracking.
- 12) All outlet valves were not exercised during the inspection. Per the District, the outlet valves were last exercised on April 27, 2021. Based on visual observations of exposed control equipment and District's comments, the outlet facilities remain fully functional.

Photo 2) Minor AC paving cracking near left abutment looking towards the right abutment.

- 3) The overgrown grass cover on the downstream slope surface needs to be mowed to a grass height between 2 to 4 inches and maintained continuously.
- 4) Repair AC at localized crack areas on the upstream slope and crest of the dam. These cracks should be repaired with a manufacturer recommended AC repair product. Vegetation and brush at the upstream slope need to be removed.

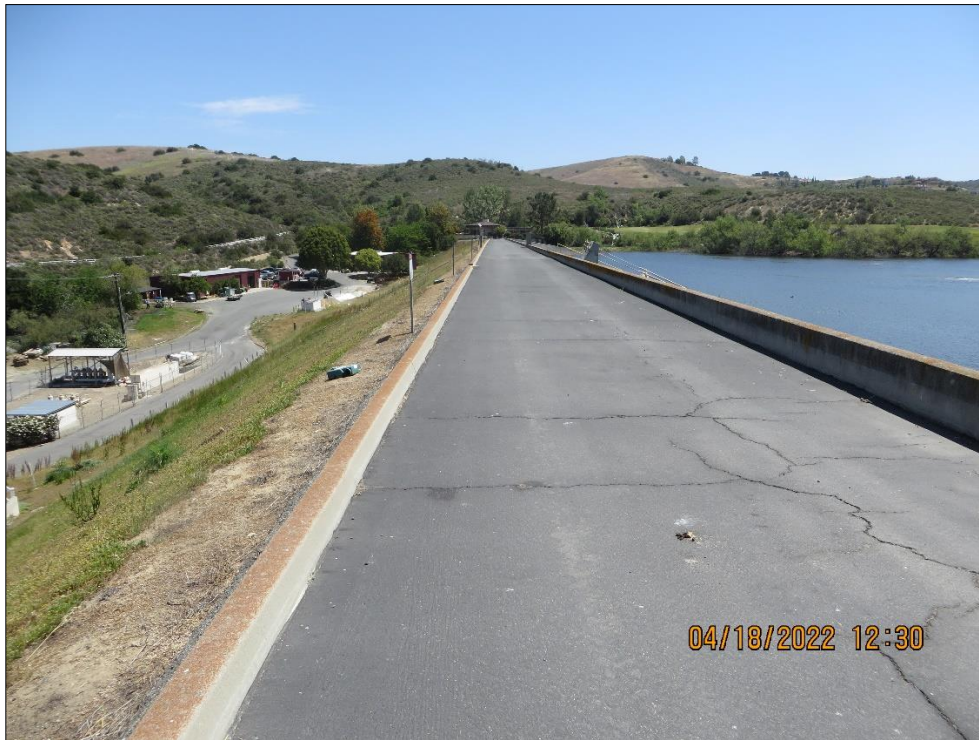
Photo 3) Minor AC paving temperature related cracking looking towards the right abutment.

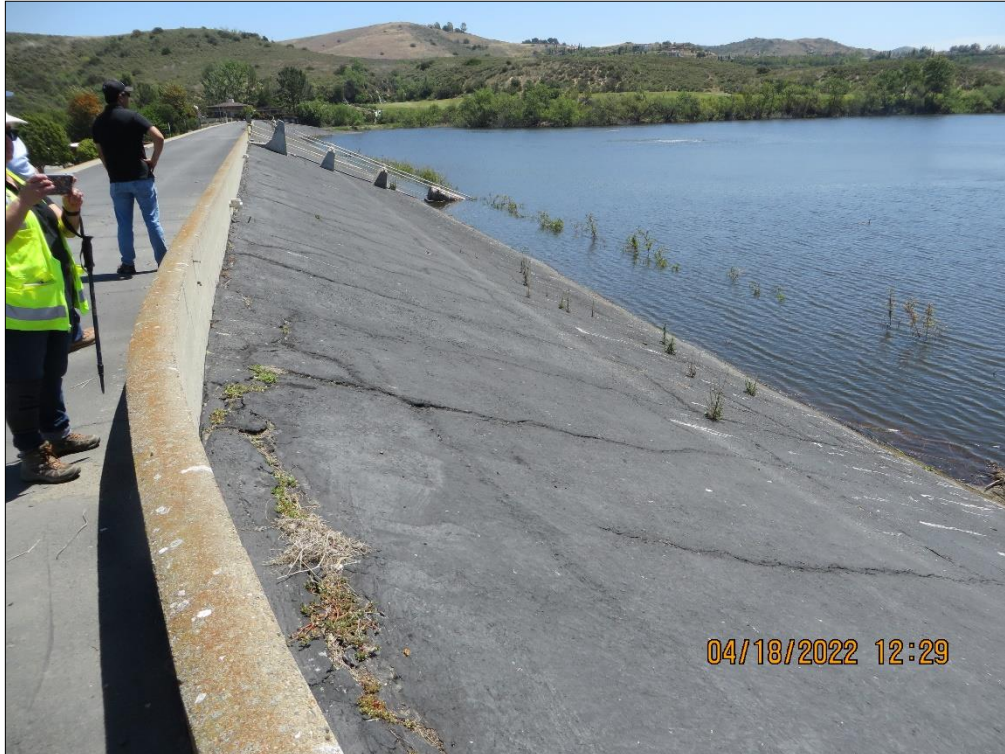
- 6) The dam grass cover has slightly overgrown since the last inspection.
- 7) There was a lack of poison at most rodent control feeder boxes.
- 8) The exposed AC-liner on the upstream slope of the dam had some vegetation and long-standing transverse and longitudinal shrinkage-expansion cracking.

Photo 4) AC-lined upstream face looking towards right abutment. Note cracks and brush in reservoir.

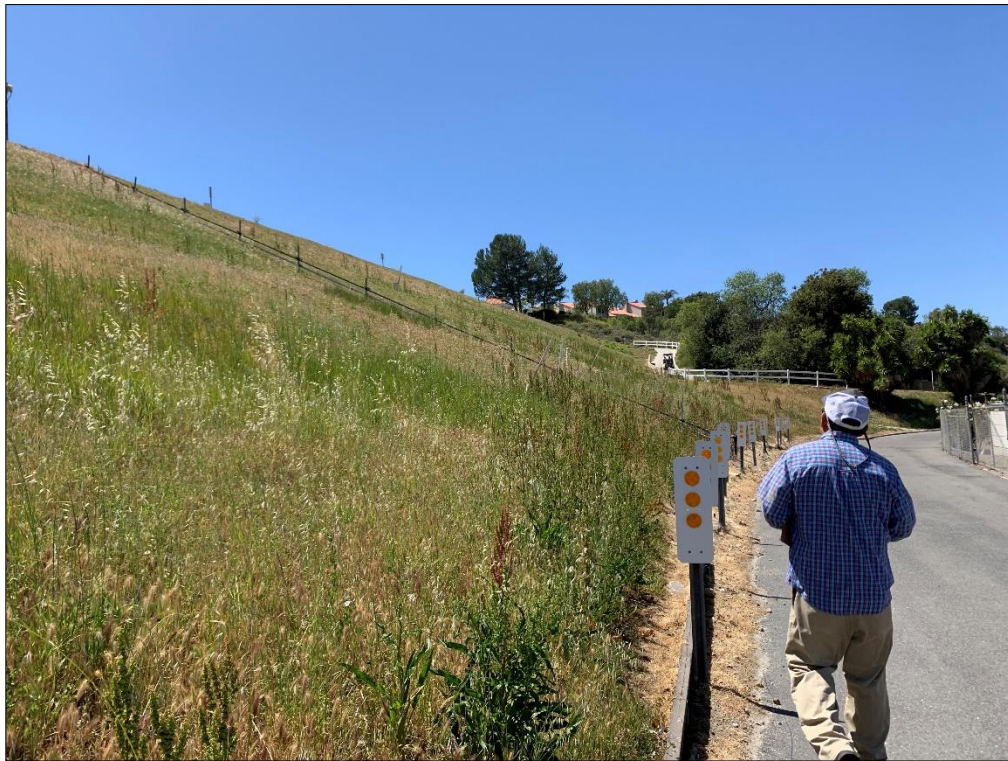
Photo 5) Downstream face looking towards the left abutment.

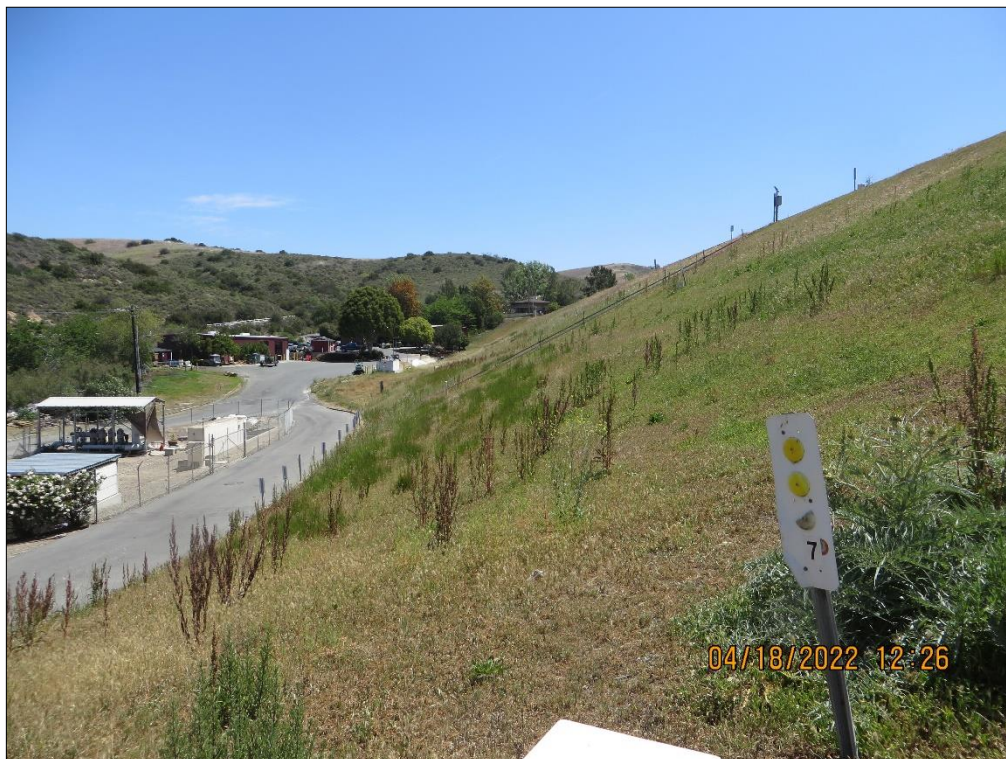
Photo 6) Downstream face looking towards the right abutment.

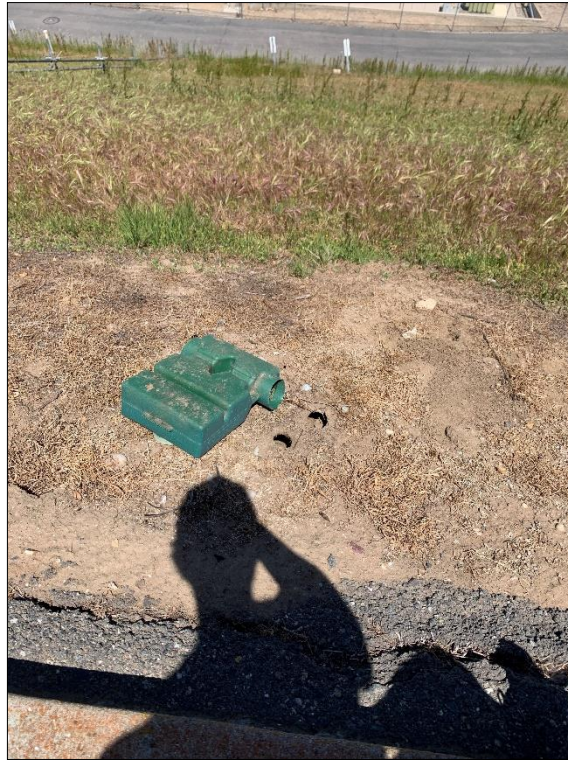
Photo 7) Empty rodent control feeder box near inactive rodent holes.

- 1) The District needs to fill the rodent control feeder boxes with poison and backfill any new rodent holes observed on the dam.
- 2) Surveyor needs to provide reservoir elevation, reservoir water temperature, air temperature and weather conditions for each survey.

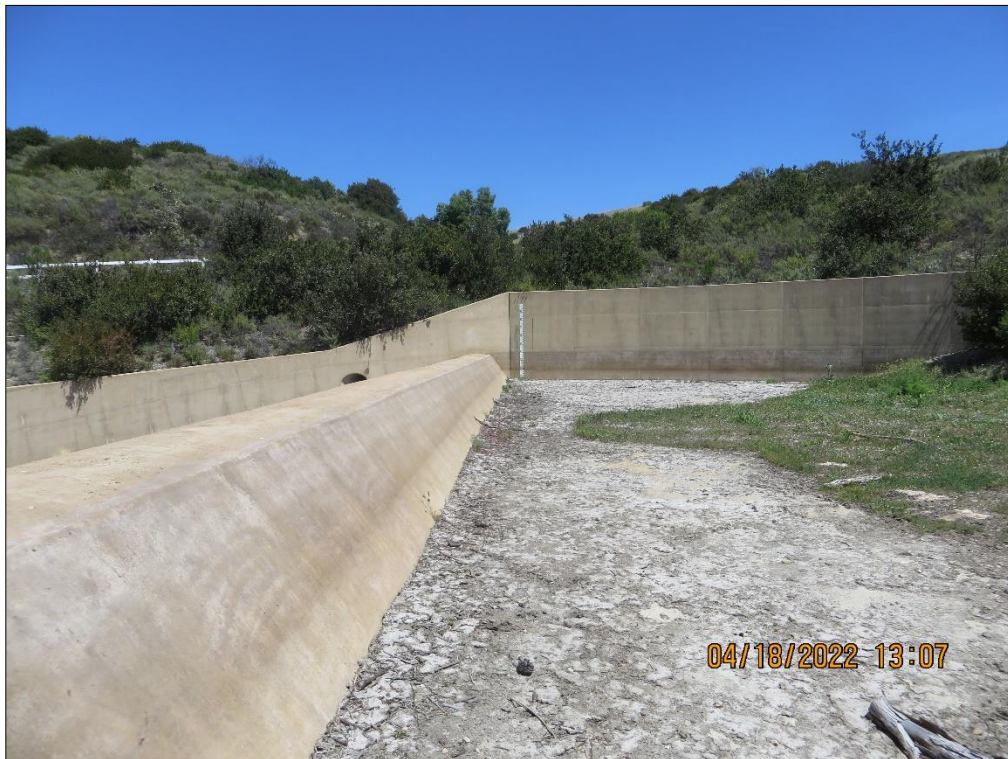
The approach and ungated ogee section open channel spillway were clear, see Photos 8 through 10. The exposed concrete wall surfaces, ogee section, rock/concrete in-fill channel bottom, and stilling basin were inspected, and no unusual conditions were found. No signs of instability were seen. Minor brush/tule growth was noticed at the end of the stilling basin, see Photo 11. The District is aware this vegetation growth has to be monitored continuously and cut as required. During this inspection along with previous inspections, the right spillway concrete wall in the upper section of the spillway channel had a vertical wall joint with approximately a 1-inch offset between concrete wall section, see Photo 9. No signs of active movement were seen. Under high spillway flows this offset could potentially result in some concrete damage along joint. During the 2022 inspection, GEI observed that the spillway wall appeared to be unchanged when compared to GEI's previous inspections.

Photo 8) Close view of the spillway control ogee section and approach.

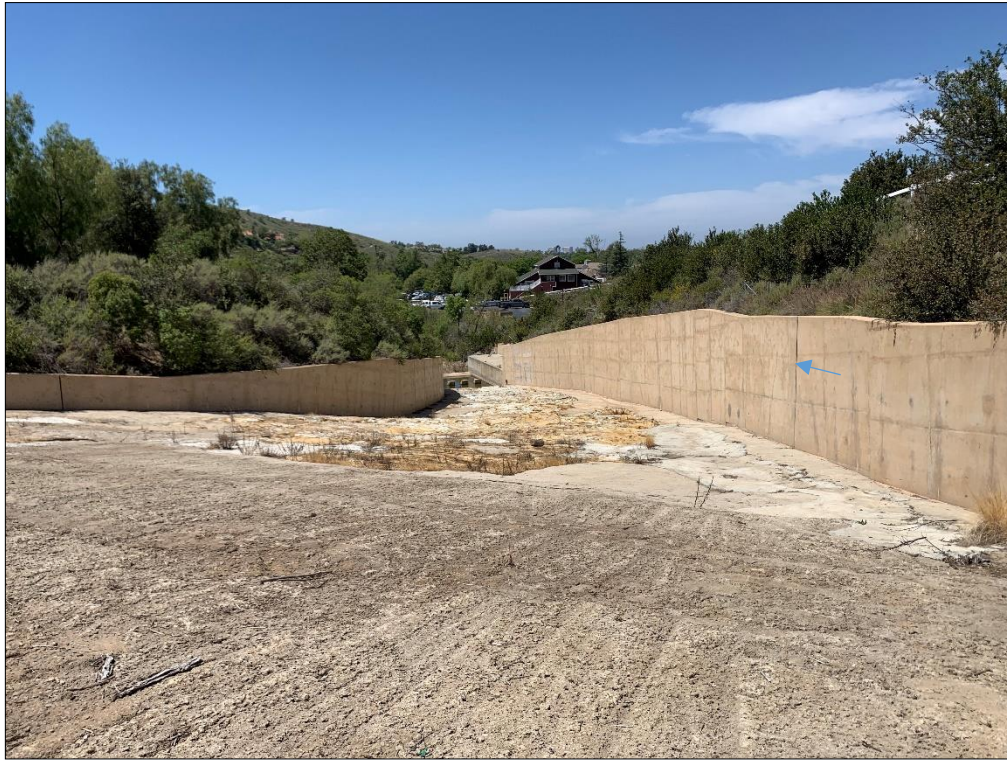
- 13) The area surrounding the 30-inch blowoff outfall has significant overgrown vegetation and the outfall could not be located.
- 14) The spillway was found clear and with no obstructions. Concrete surfaces and exposed rock surfaces had no observed signs of structural deficiencies. GEI did examine and noted that the longstanding one-inch vertical joint offset at the right spillway concrete wall had not changed from GEI's past observations.

Photo 9) Spillway channel looking downstream, note vertical right wall joint offset.

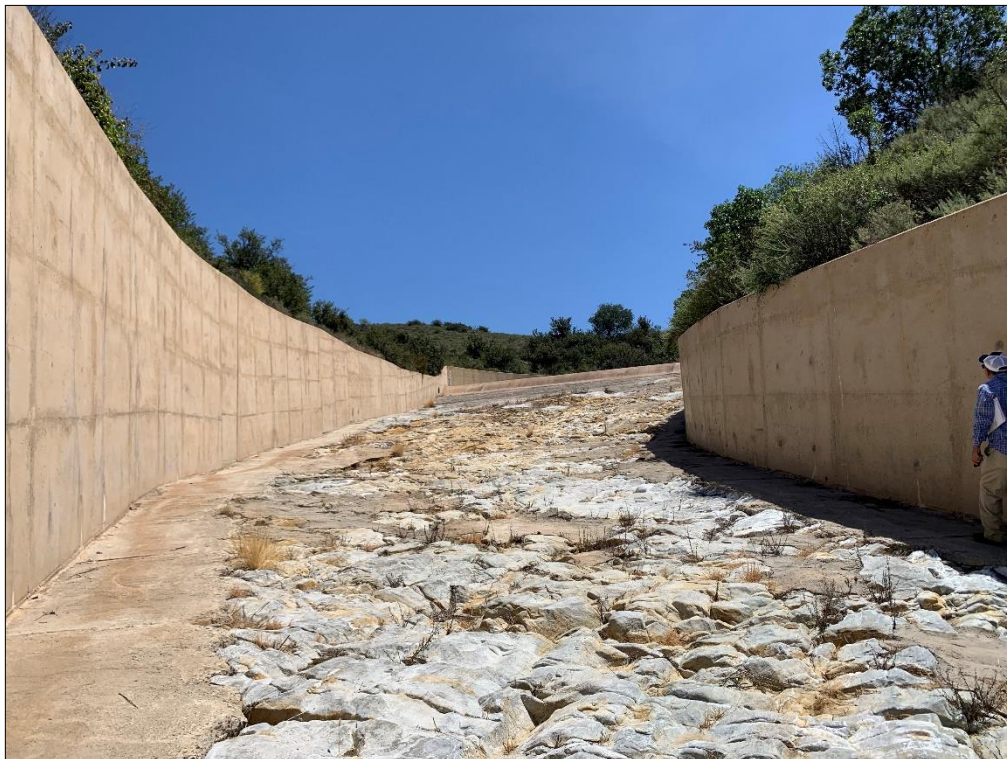
Photo 10) Spillway channel concrete walls and rock floor looking upstream.

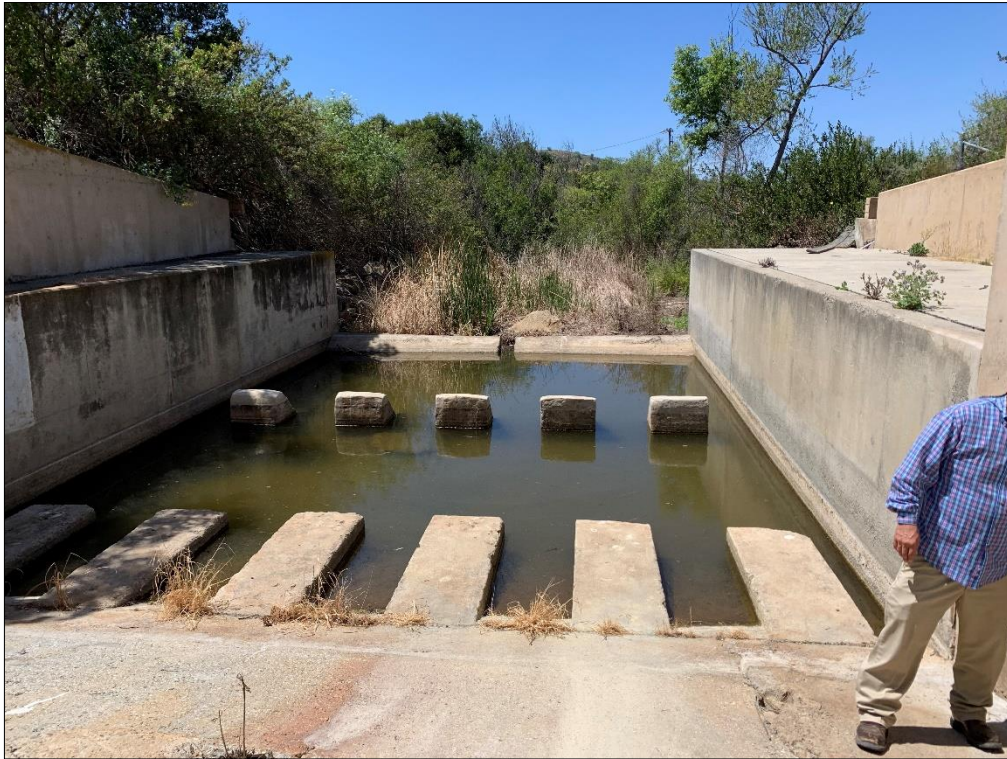
Photo 11) Close up view of spillway stilling basin, note brush/tule growth downstream.

- 7) The District needs to continue monitoring brush/tule growth at the spillway stilling basin and cut when appropriate to avoid any damage to spillway concrete or impacts to spillway operability.

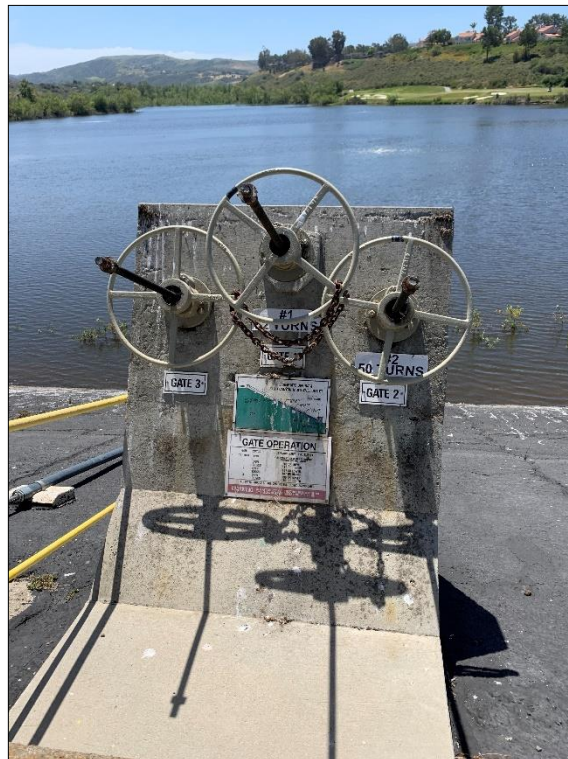
Photo 12) Outlet upstream valves' operating equipment.

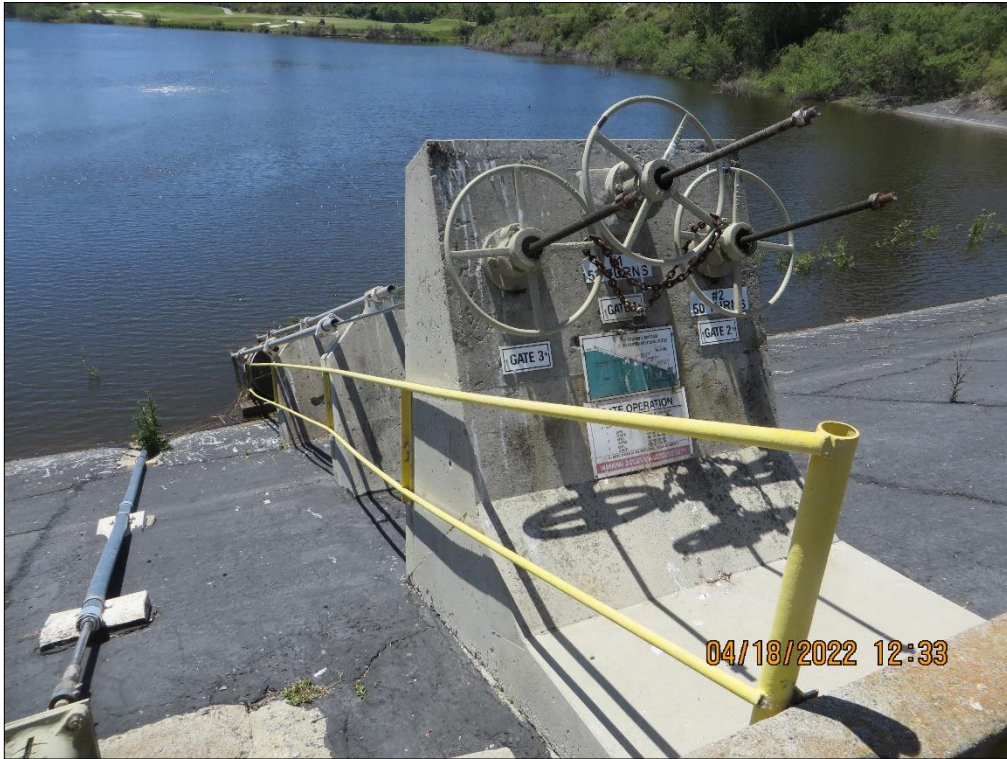
Photo 13) Outlet valve controls and stems.

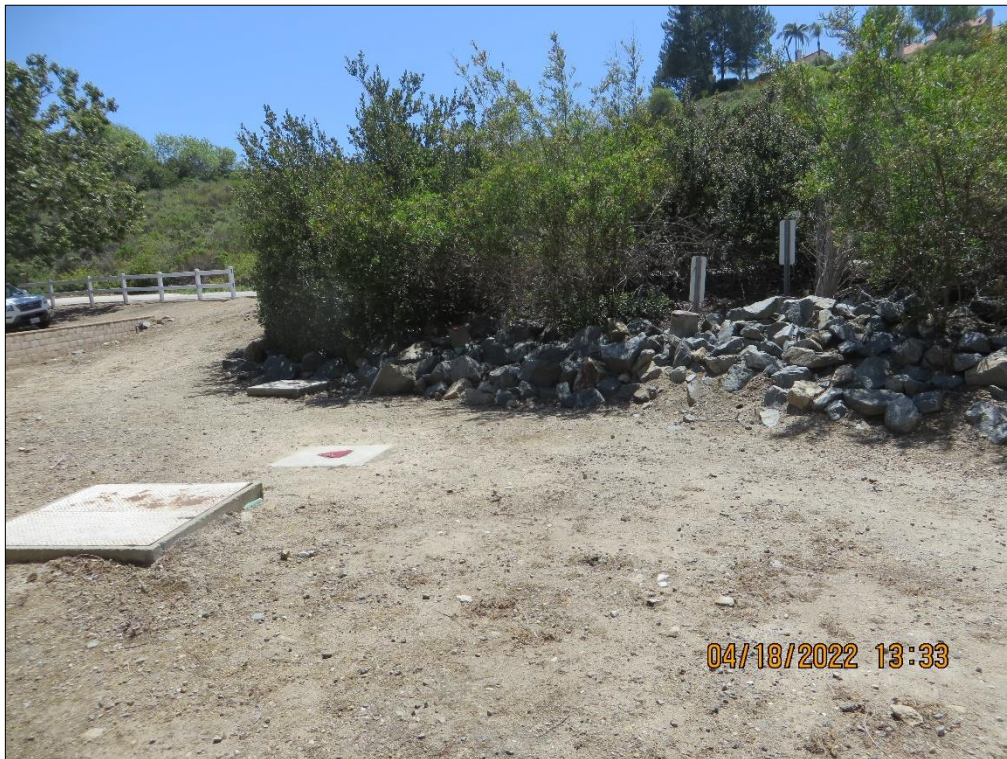
Photo 14) Location of downstream outlet control valves.

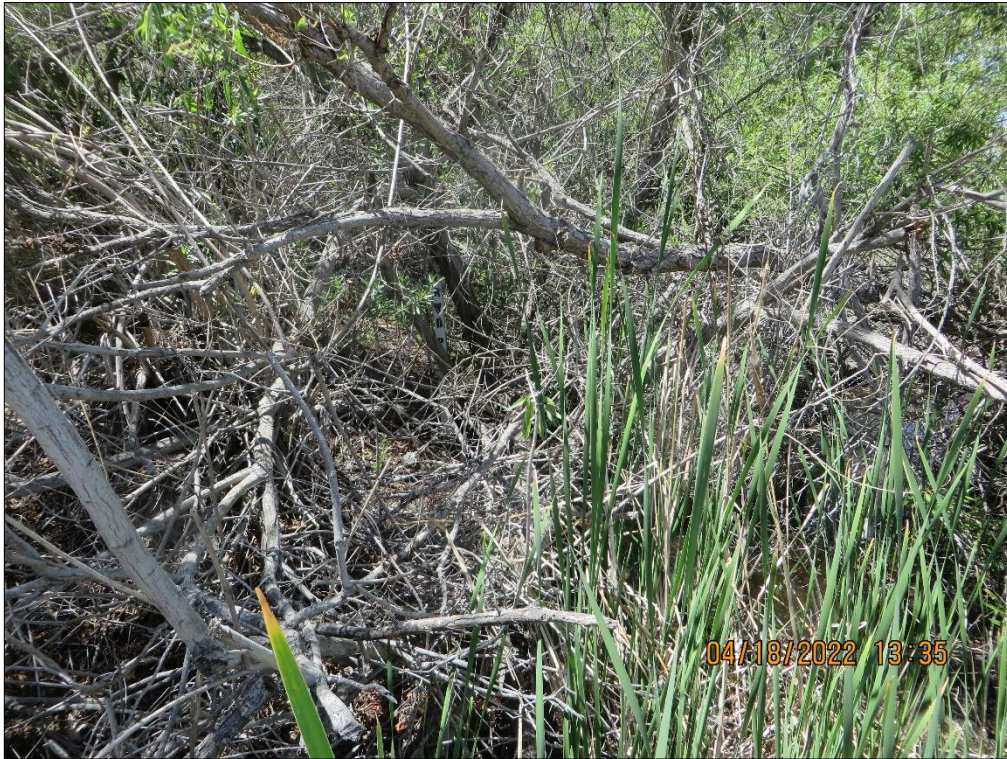
Photo 15) Overgrown vegetation at 30-inch blowoff discharge outfall.

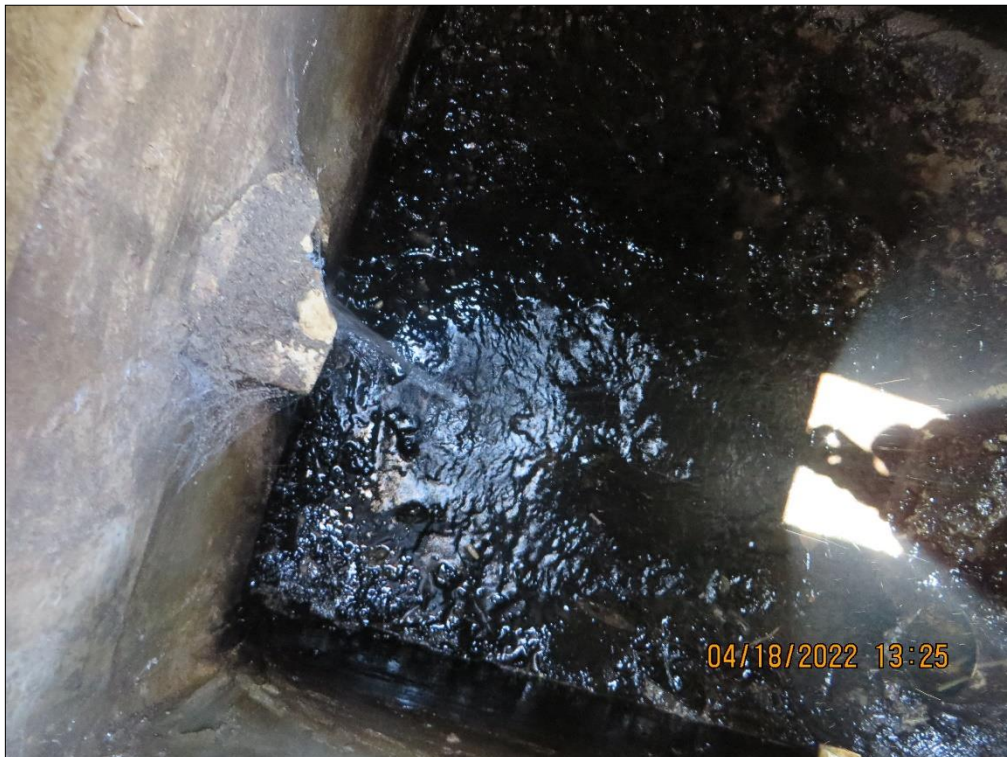
Seepage flow rates continue to be monitored and measured monthly by District staff. A small seepage flow, estimated at 1.0 gpm, was observed in the Left Subdrain and the Right Subdrain was dry during this inspection. The observed seepage conditions were within past levels and based on past records and observations. Seepage water did not appear to have turbidity and appeared to be clear, see Photo 16.

Photo 16) Seepage at left subdrain.

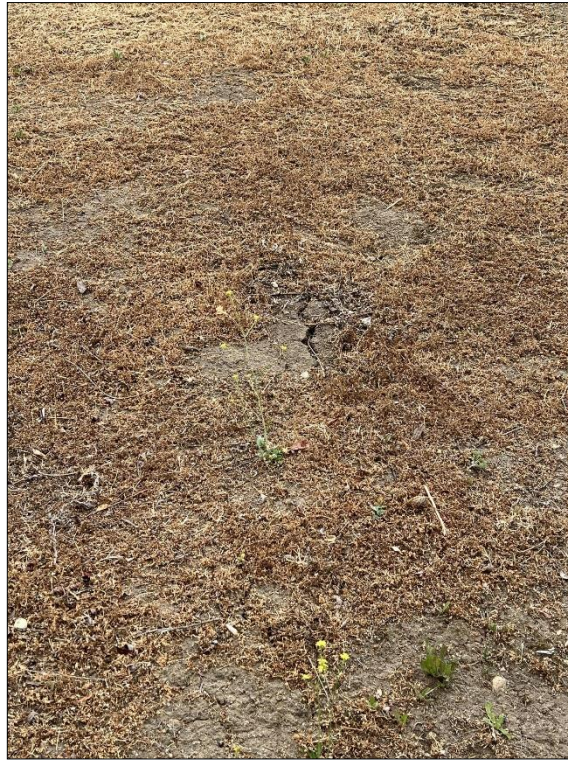
A field evaluation and inspection was conducted by DSOD and the District on June 13, 2022. GEI was not in attendance during the inspection. During the inspection, the District saw cracks along the downstream face of the dam, see Photo 17. GEI has reviewed the photo and the cracking appears to be from desiccation of the surface soil. This is due to having inspections during different times of the year.

Photo 17) Soil desiccation cracking near piezometer P-7. Photo taken by IRWD on 6/13/2022 DSOD inspection.
