Annual Surveillance Report January 2021 to December 2021 for Sand Canyon Dam DSOD Dam No. 1029-002

Irvine, California

September 29, 2022
GEI Project No. 1901888

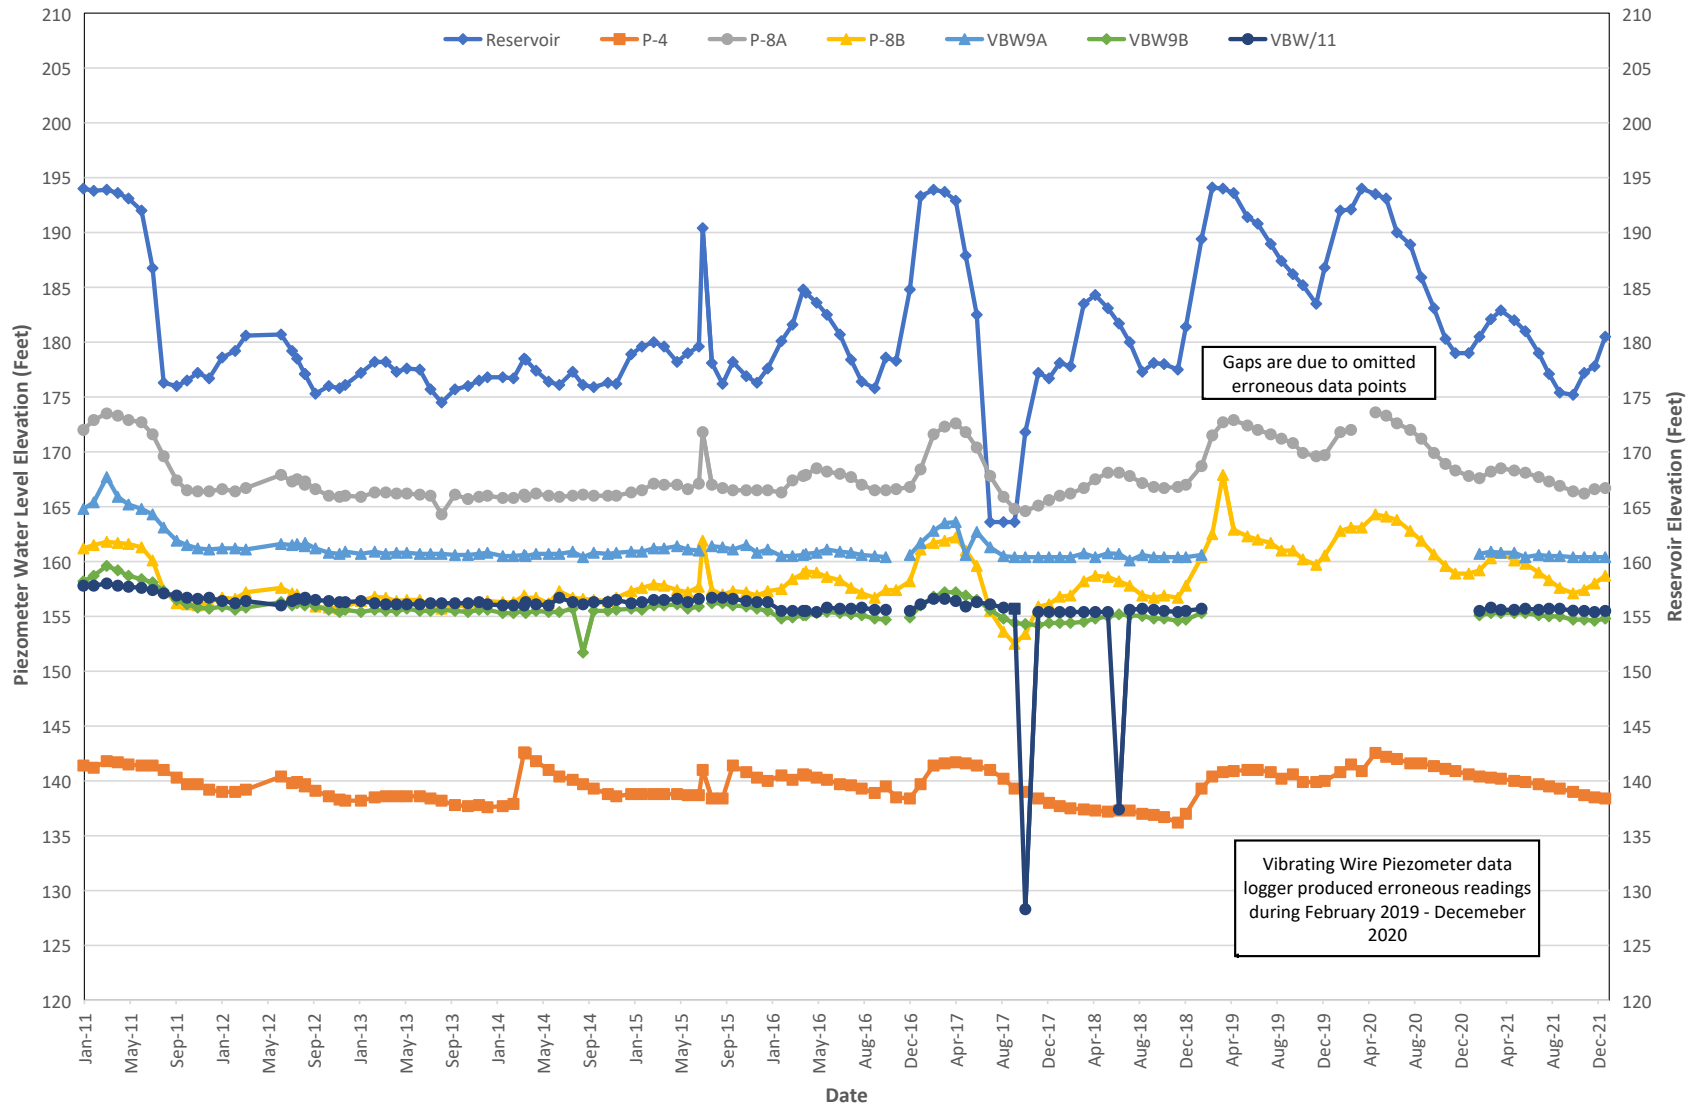
Figure 11
SAND CANYON DAM
HISTORICAL PIEZOMETER AND RESERVOIR WATER SURFACE ELEVATIONS
PIEZOMETERS P-4, P-8A, P-8B, VBW9A, VBW9B, AND VBW/11
JANUARY 2011 THROUGH DECEMBER 2021

Piezometers P-4, P-8A, P-8B, VBW9A, VBW9B and VBW/11 are located along another plane near the maximum cross section of the dam. Piezometers P-8A & P-8B are located on the crest of the dam, Piezometer P-4 is located near the toe of the dam, and Piezometers VBW9A & VBW9B are located along the downstream face of the dam along with Piezometer VBW/11. Graphs of the water levels during the two-year period from January 2020 through December 2021 are shown on Figure 6, and graphs for the historical period from January 2011 through December 2021 are shown on Figure 11. Piezometers P-8A, VBW9A, and VBW/11 are installed within the dam embankment. Piezometers P-8A continues to respond to reservoir water surface fluctuations. Vibrating wire piezometers VBW9A, VBW9B, and VBW/11 were producing erroneous digital readings from February 2019 to December 2020. As stated previously, the District fixed the data logger problem and provided readings for the 2021 review period. For the 2021 review period, VBW9A was mostly dry, see Figure 6. The water level observed in the piezometers during the 2021 review period was consistent with historical levels (Figure 11). It should be noted that on March 24, 2020, the reading for P-8A shown in Figure 6 appears to be in error with a reading (199.1 ft) of about 5.6 ft above the reservoir level. It was noted there was rain during March 2020 that could potentially have impacted the reading. The level of P-8A returned to historic levels during April 2020. Piezometers P-4 and P-8B are installed in foundation bedrock, and VBW9B was installed in foundation alluvium. Piezometers P-8B generally responded to reservoir water surface fluctuations, while fluctuation in Piezometer P-4 appear related to rainwater. During the review period, VBW9B and VBW/11 had minor fluctuations and the range between maximum and minimum levels were 0.7 ft and 0.4 ft respectively. The water levels observed in these

piezometers during this 2021 review period were consistent with historical levels (Figures 6 and 11).

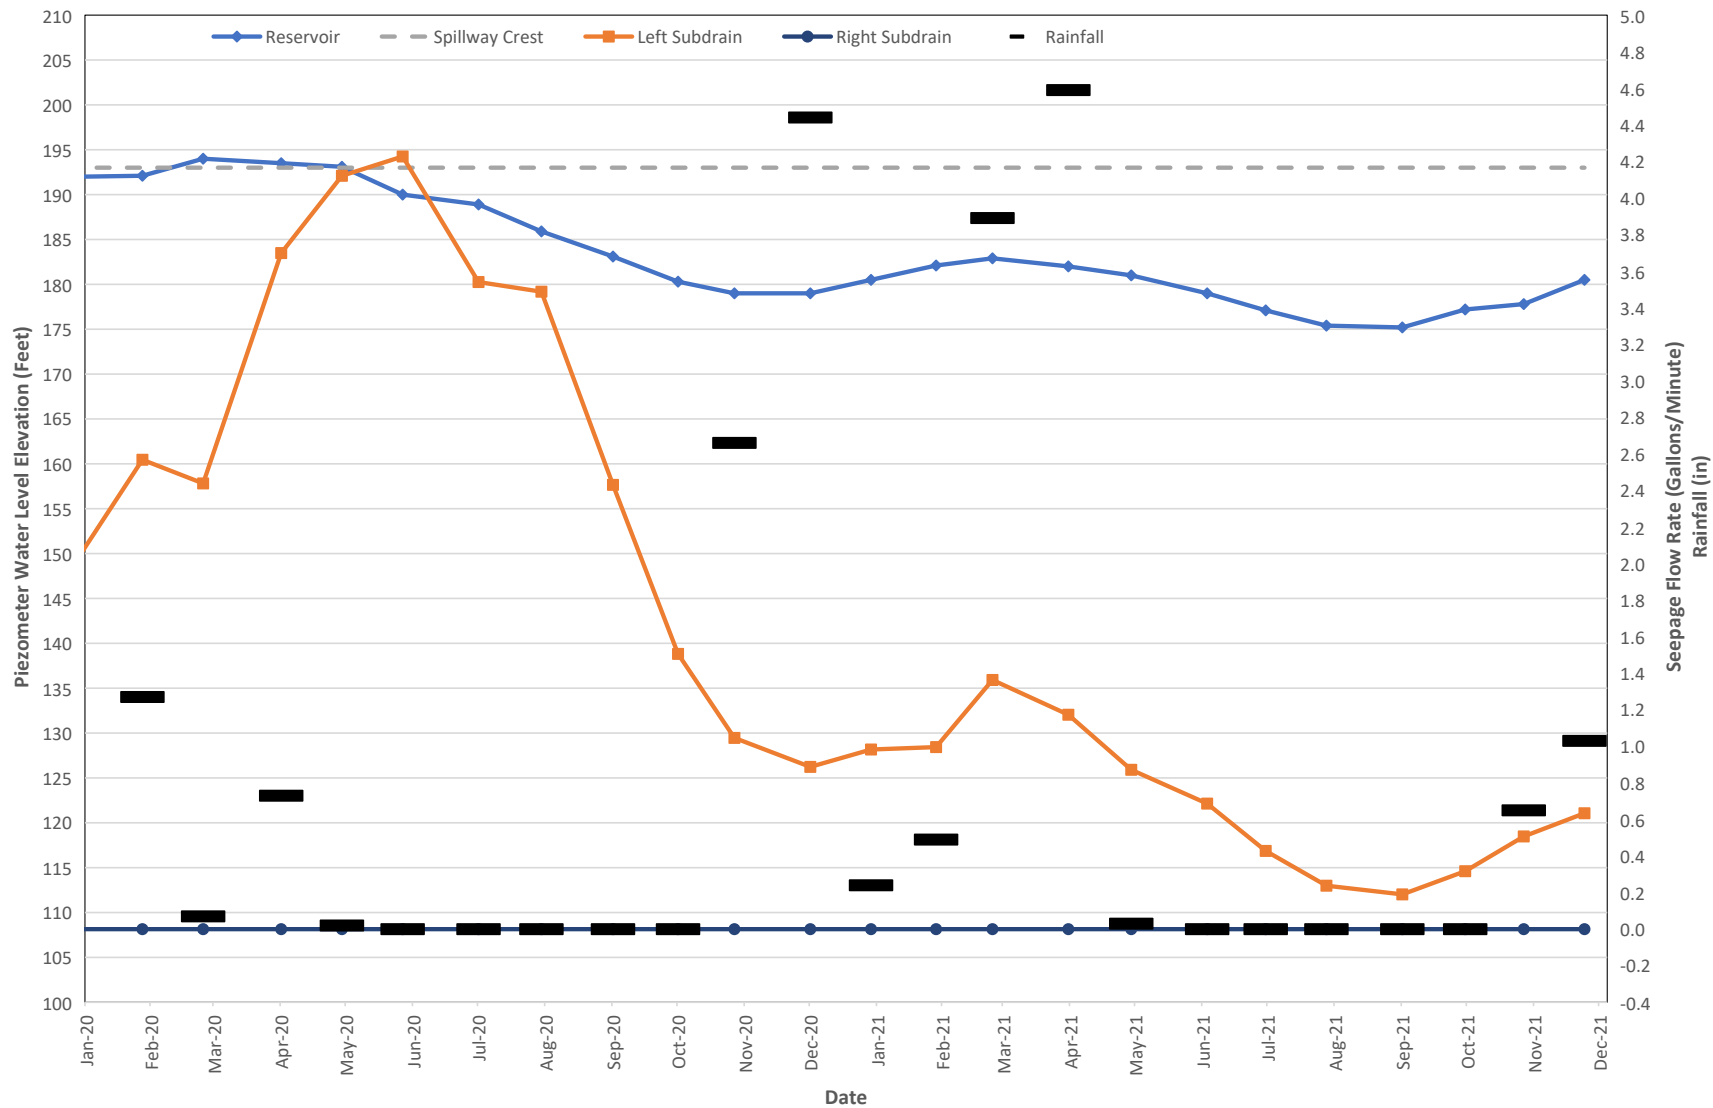
Figure 14
SAND CANYON DAM
2-YR SEEPAGE, RESERVOIR WATER SURFACE ELEVATIONS AND RAINFALL
JANUARY 2020 THROUGH DECEMBER 2021

Figure 14 represents the seepage flow rates from the Left and Right Subdrains versus the reservoir water surface elevations for the two-year period from January 2020 through December 2021. Figure 15 covers the historical period from January 2011 through December 2021. Tabulated data for the seepage flow rates is presented in Table 2.
